2016 ANNUAL LANDFILL INSPECTION REPORT

GRAND RIVER DAM AUTHORITY LANDFILL

GRAND RIVER ENERGY CENTER

JANUARY 13, 2017

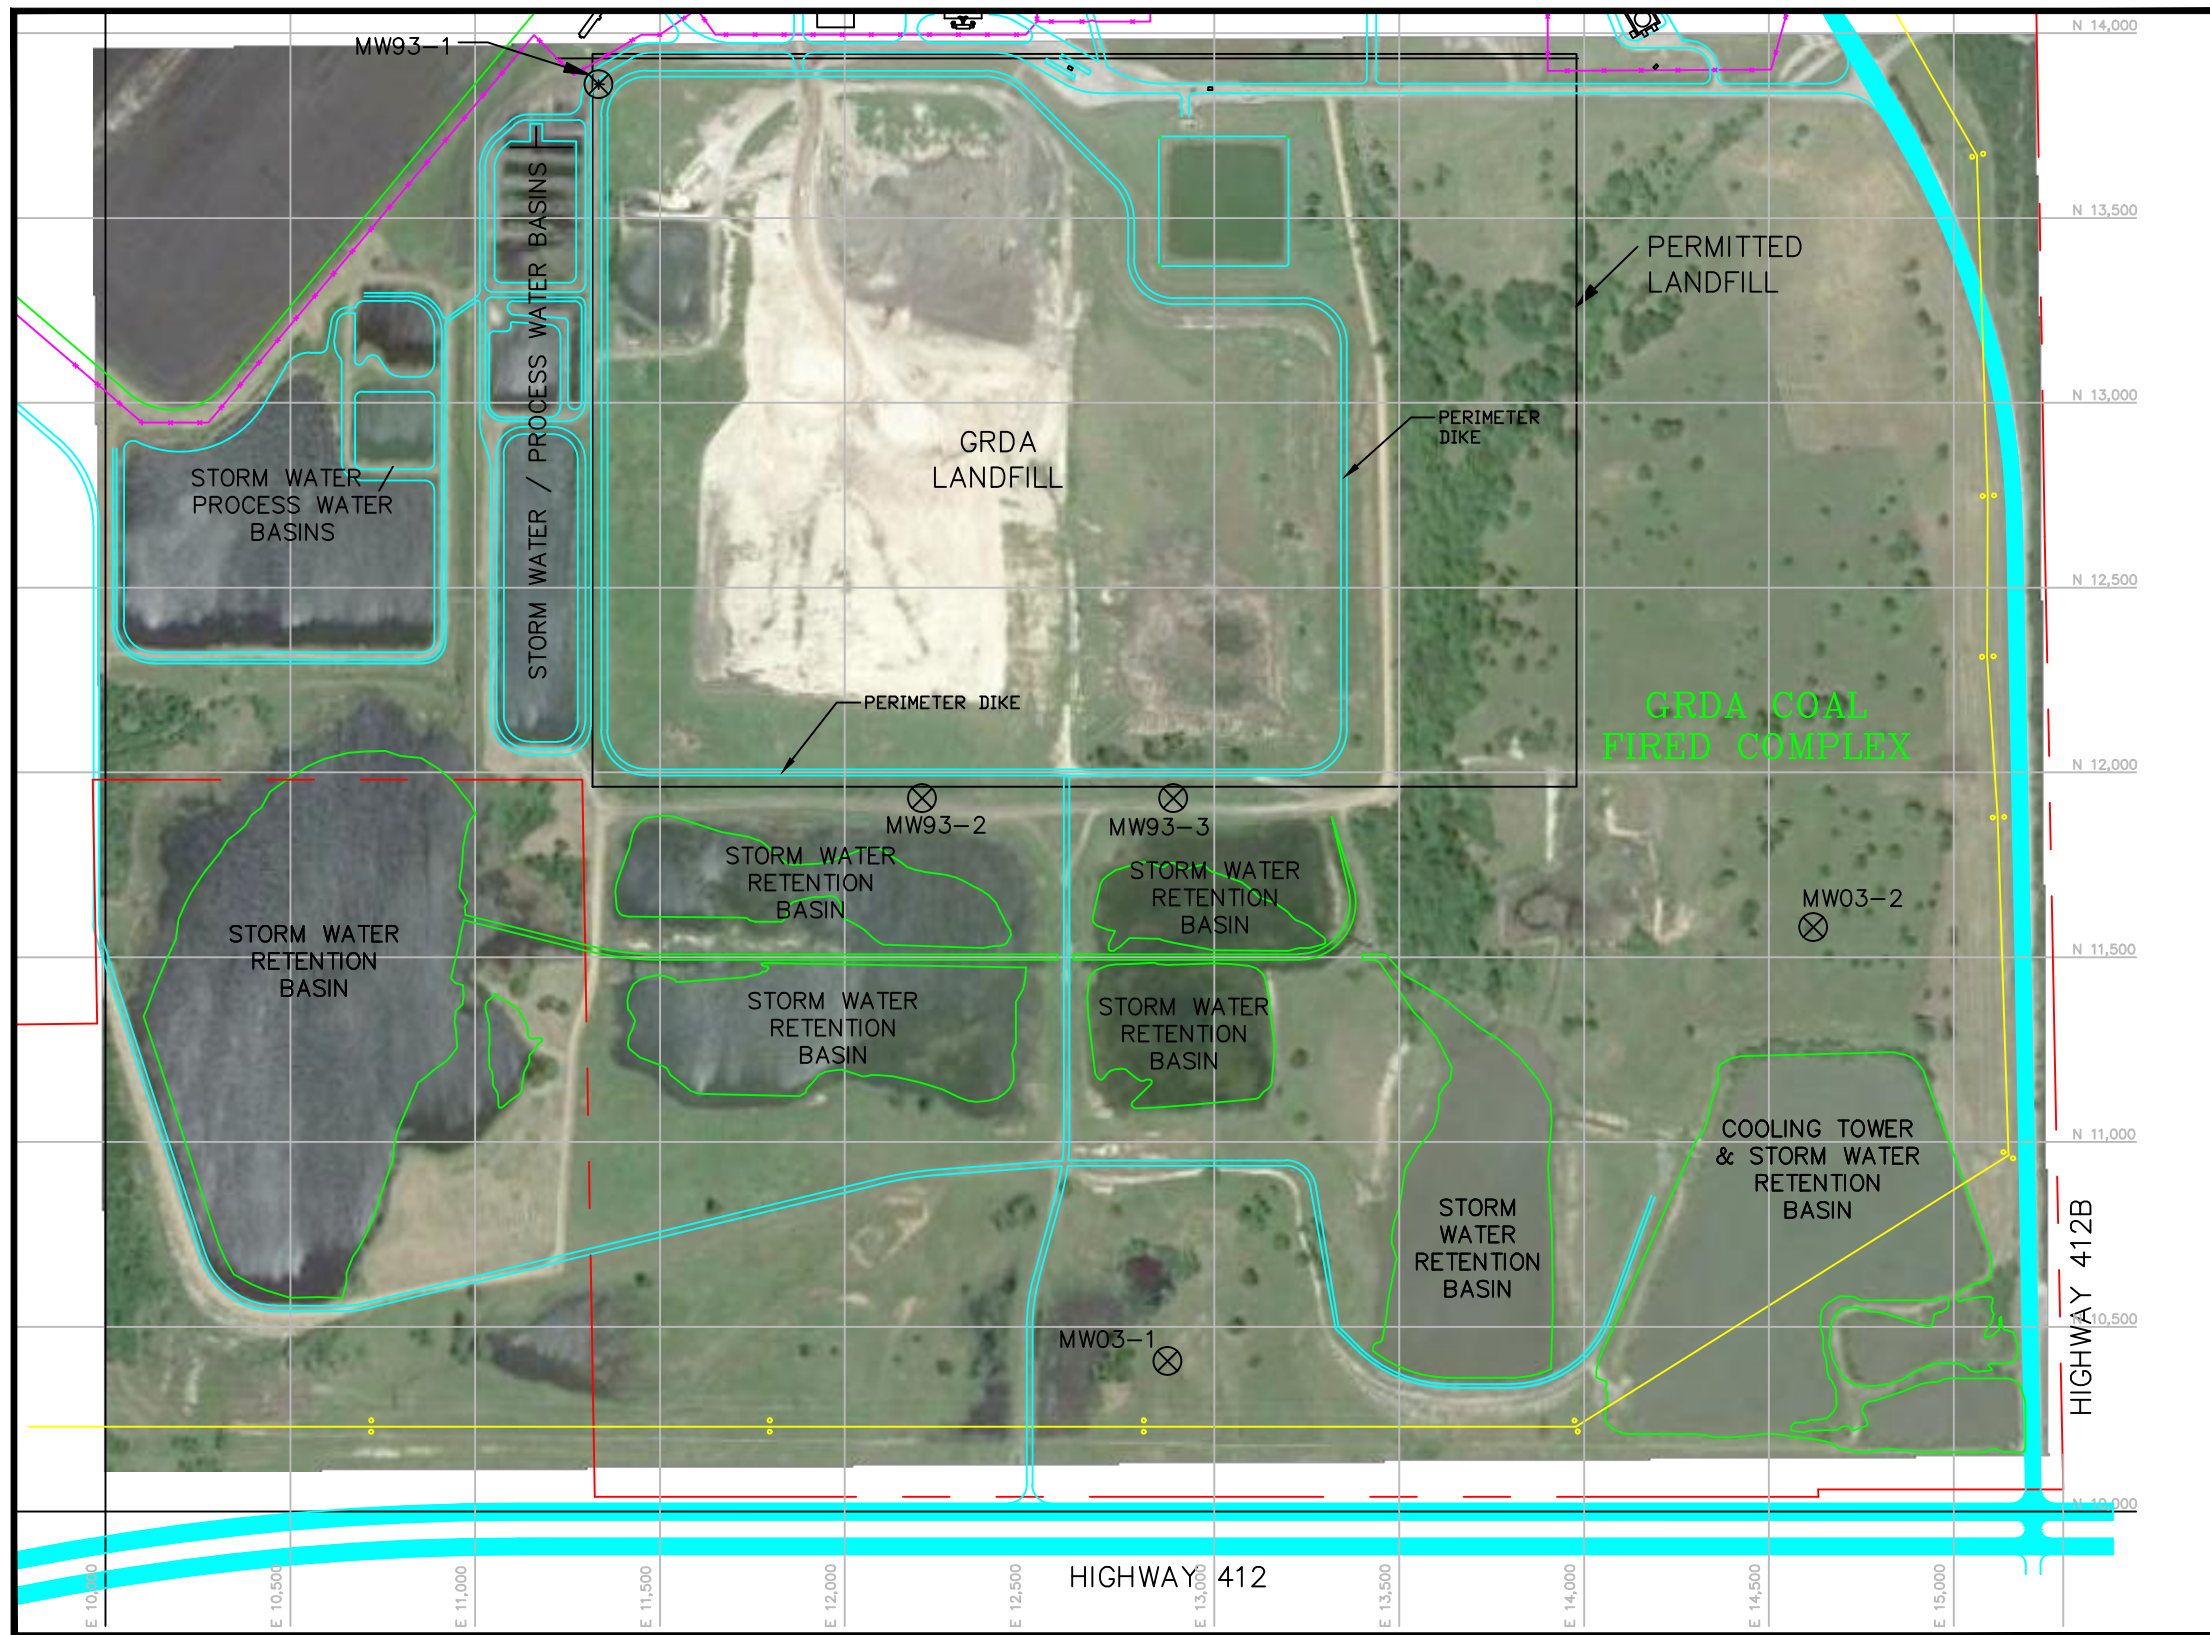
| APPROVED BY: DME | SCALE: AS SHOWN | PROJECT NUMBER: 1986-013 | DRAWING NUMBER: FIGURE 1 | REV: |

The current landfill consists of a perimeter dike that encompasses a 70 acre portion of the permitted landfill area as shown in **Figure 1**. Approximately 47 acres of this area has been utilized and remains active to date. The southern half of this area is near the maximum design elevation according to the facility Closure Plan. The elevation of the crest along the southern edge of the landfill is reported to be approximately 675 feet above mean sea level (AMSL). The lowest point along the toe of dike is reported to be at approximately 610 feet AMSL. An intermediate or final cover has been installed on the southern and western exterior slopes of the landfill. These slopes are well vegetated and maintained. Precipitation run-off from the exterior slopes is collected within the wastewater impoundments around the landfill. . The eastern and northern slopes of the active landfill are within the limits of the landfill perimeter dike. Precipitation run-off from the active landfill area is collected within the permitted landfill area and evaporated or drained into the permitted industrial wastewater treatment system.

Based on the visual inspection of the landfill, the geometry does not appear to have changed significantly compared to the conditions documented in the 2015 annual landfill inspection report or the aerial photograph depicted in **Figure 1**. Primary fill activities remain at the top of the landfill and within the northern half of the active area. Intermediate or final cover was observed on the western and southern exterior slopes of the landfill with established and maintained vegetation.
