2017 ANNUAL LANDFILL INSPECTION REPORT

GRAND RIVER DAM AUTHORITY LANDFILL

GRAND RIVER ENERGY CENTER

JANUARY 12, 2018

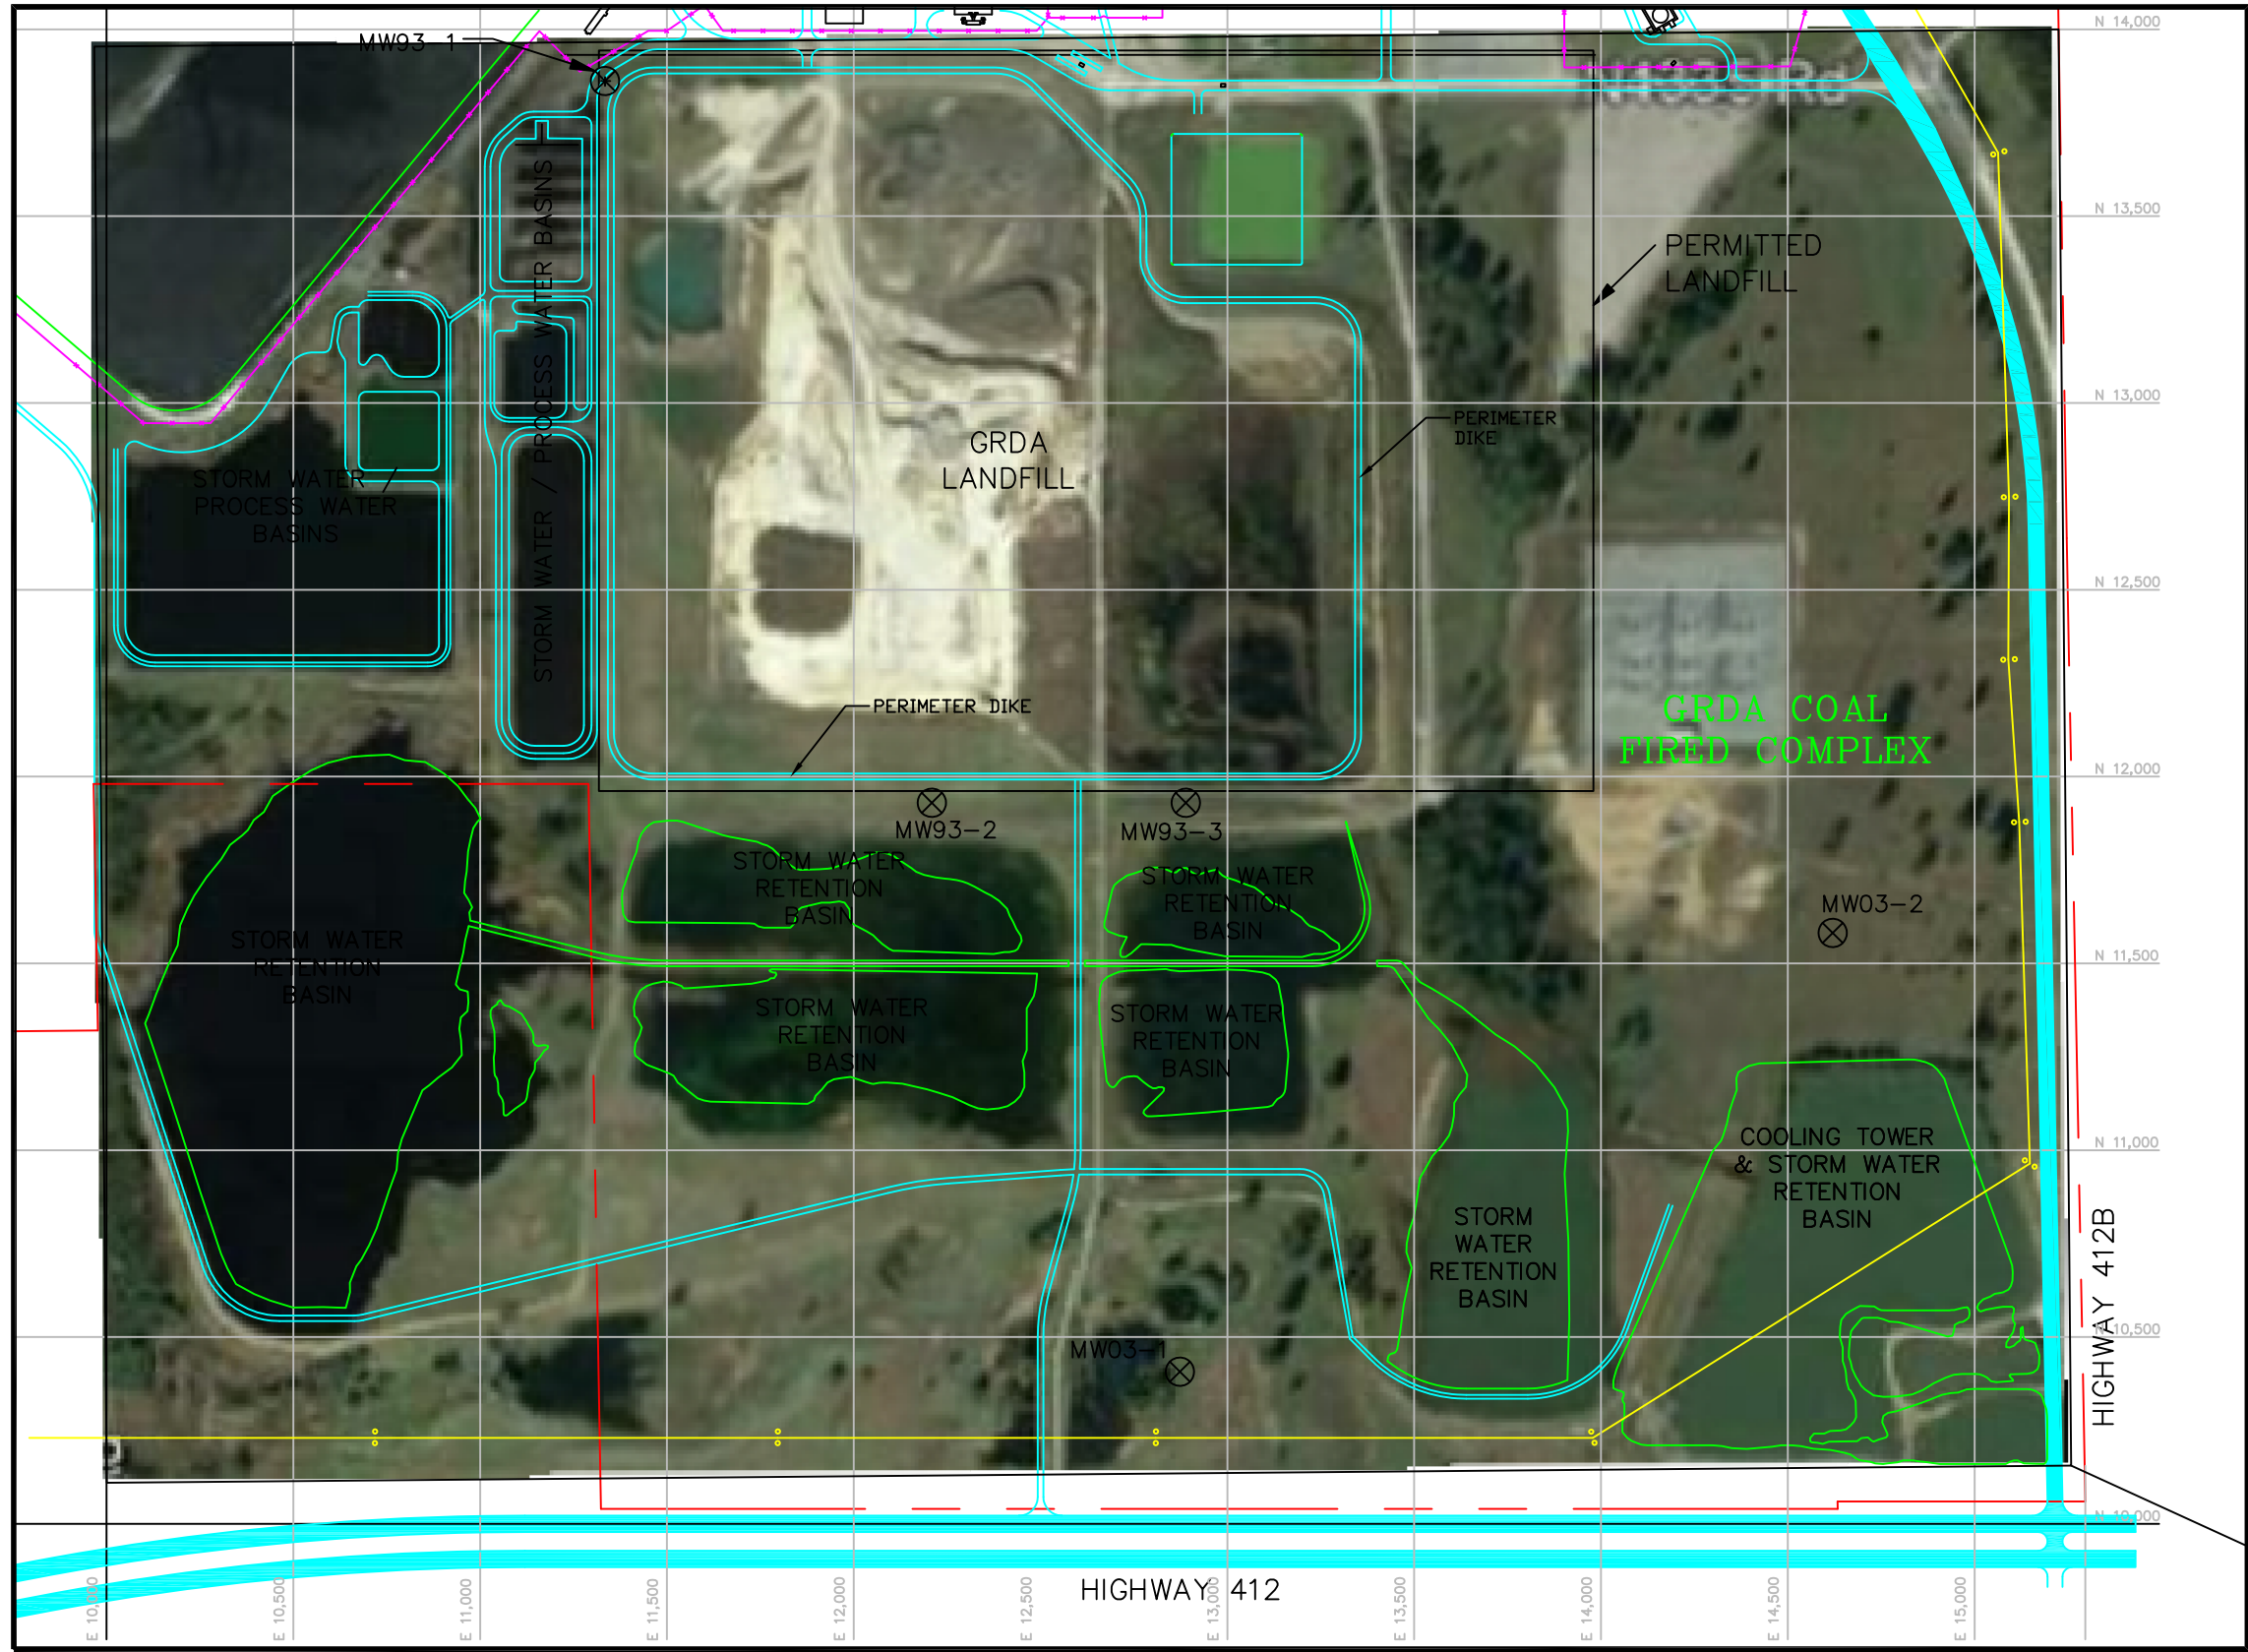
SITE MAP
GRAND RIVER DAM AUTHORITY LANDFILL
CHOUTEAU, OKLAHOMA

The current landfill consists of a perimeter dike that encompasses a 70 acre portion of the permitted landfill area as shown in **Figure 1**. Approximately 47 acres of this area have been utilized and remain active to date. The southern half of this area is near the maximum design elevation according to the facility Closure Plan. The elevation of the crest along the southern edge of the landfill is reported to be approximately 675 feet above mean sea level (AMSL). The lowest point along the toe of dike is reported to be at approximately 610 feet AMSL. An intermediate or final cover has been installed on the southern and western exterior slopes of the landfill. These slopes are well vegetated and maintained. Precipitation run-off from the exterior slopes is collected within the wastewater impoundments around the landfill. The eastern and northern slopes of the active landfill are within the limits of the landfill perimeter dike. Precipitation run-off from the active landfill area is collected within the permitted landfill area and evaporated or drained into the permitted industrial wastewater treatment system.

Based on the visual inspection of the landfill, the geometry does not appear to have changed significantly compared to the conditions documented in the 2016 annual landfill inspection report or the aerial photograph depicted in **Figure 1**. Primary fill activities remain at the top of the landfill and within the northern half of the active area. Intermediate or final cover was observed on the western and southern exterior slopes of the landfill with established and maintained vegetation.
