# **2018 ANNUAL LANDFILL INSPECTION REPORT**

**GRAND RIVER DAM AUTHORITY LANDFILL**

**GRAND RIVER ENERGY CENTER**

**DECEMBER 21, 2018**

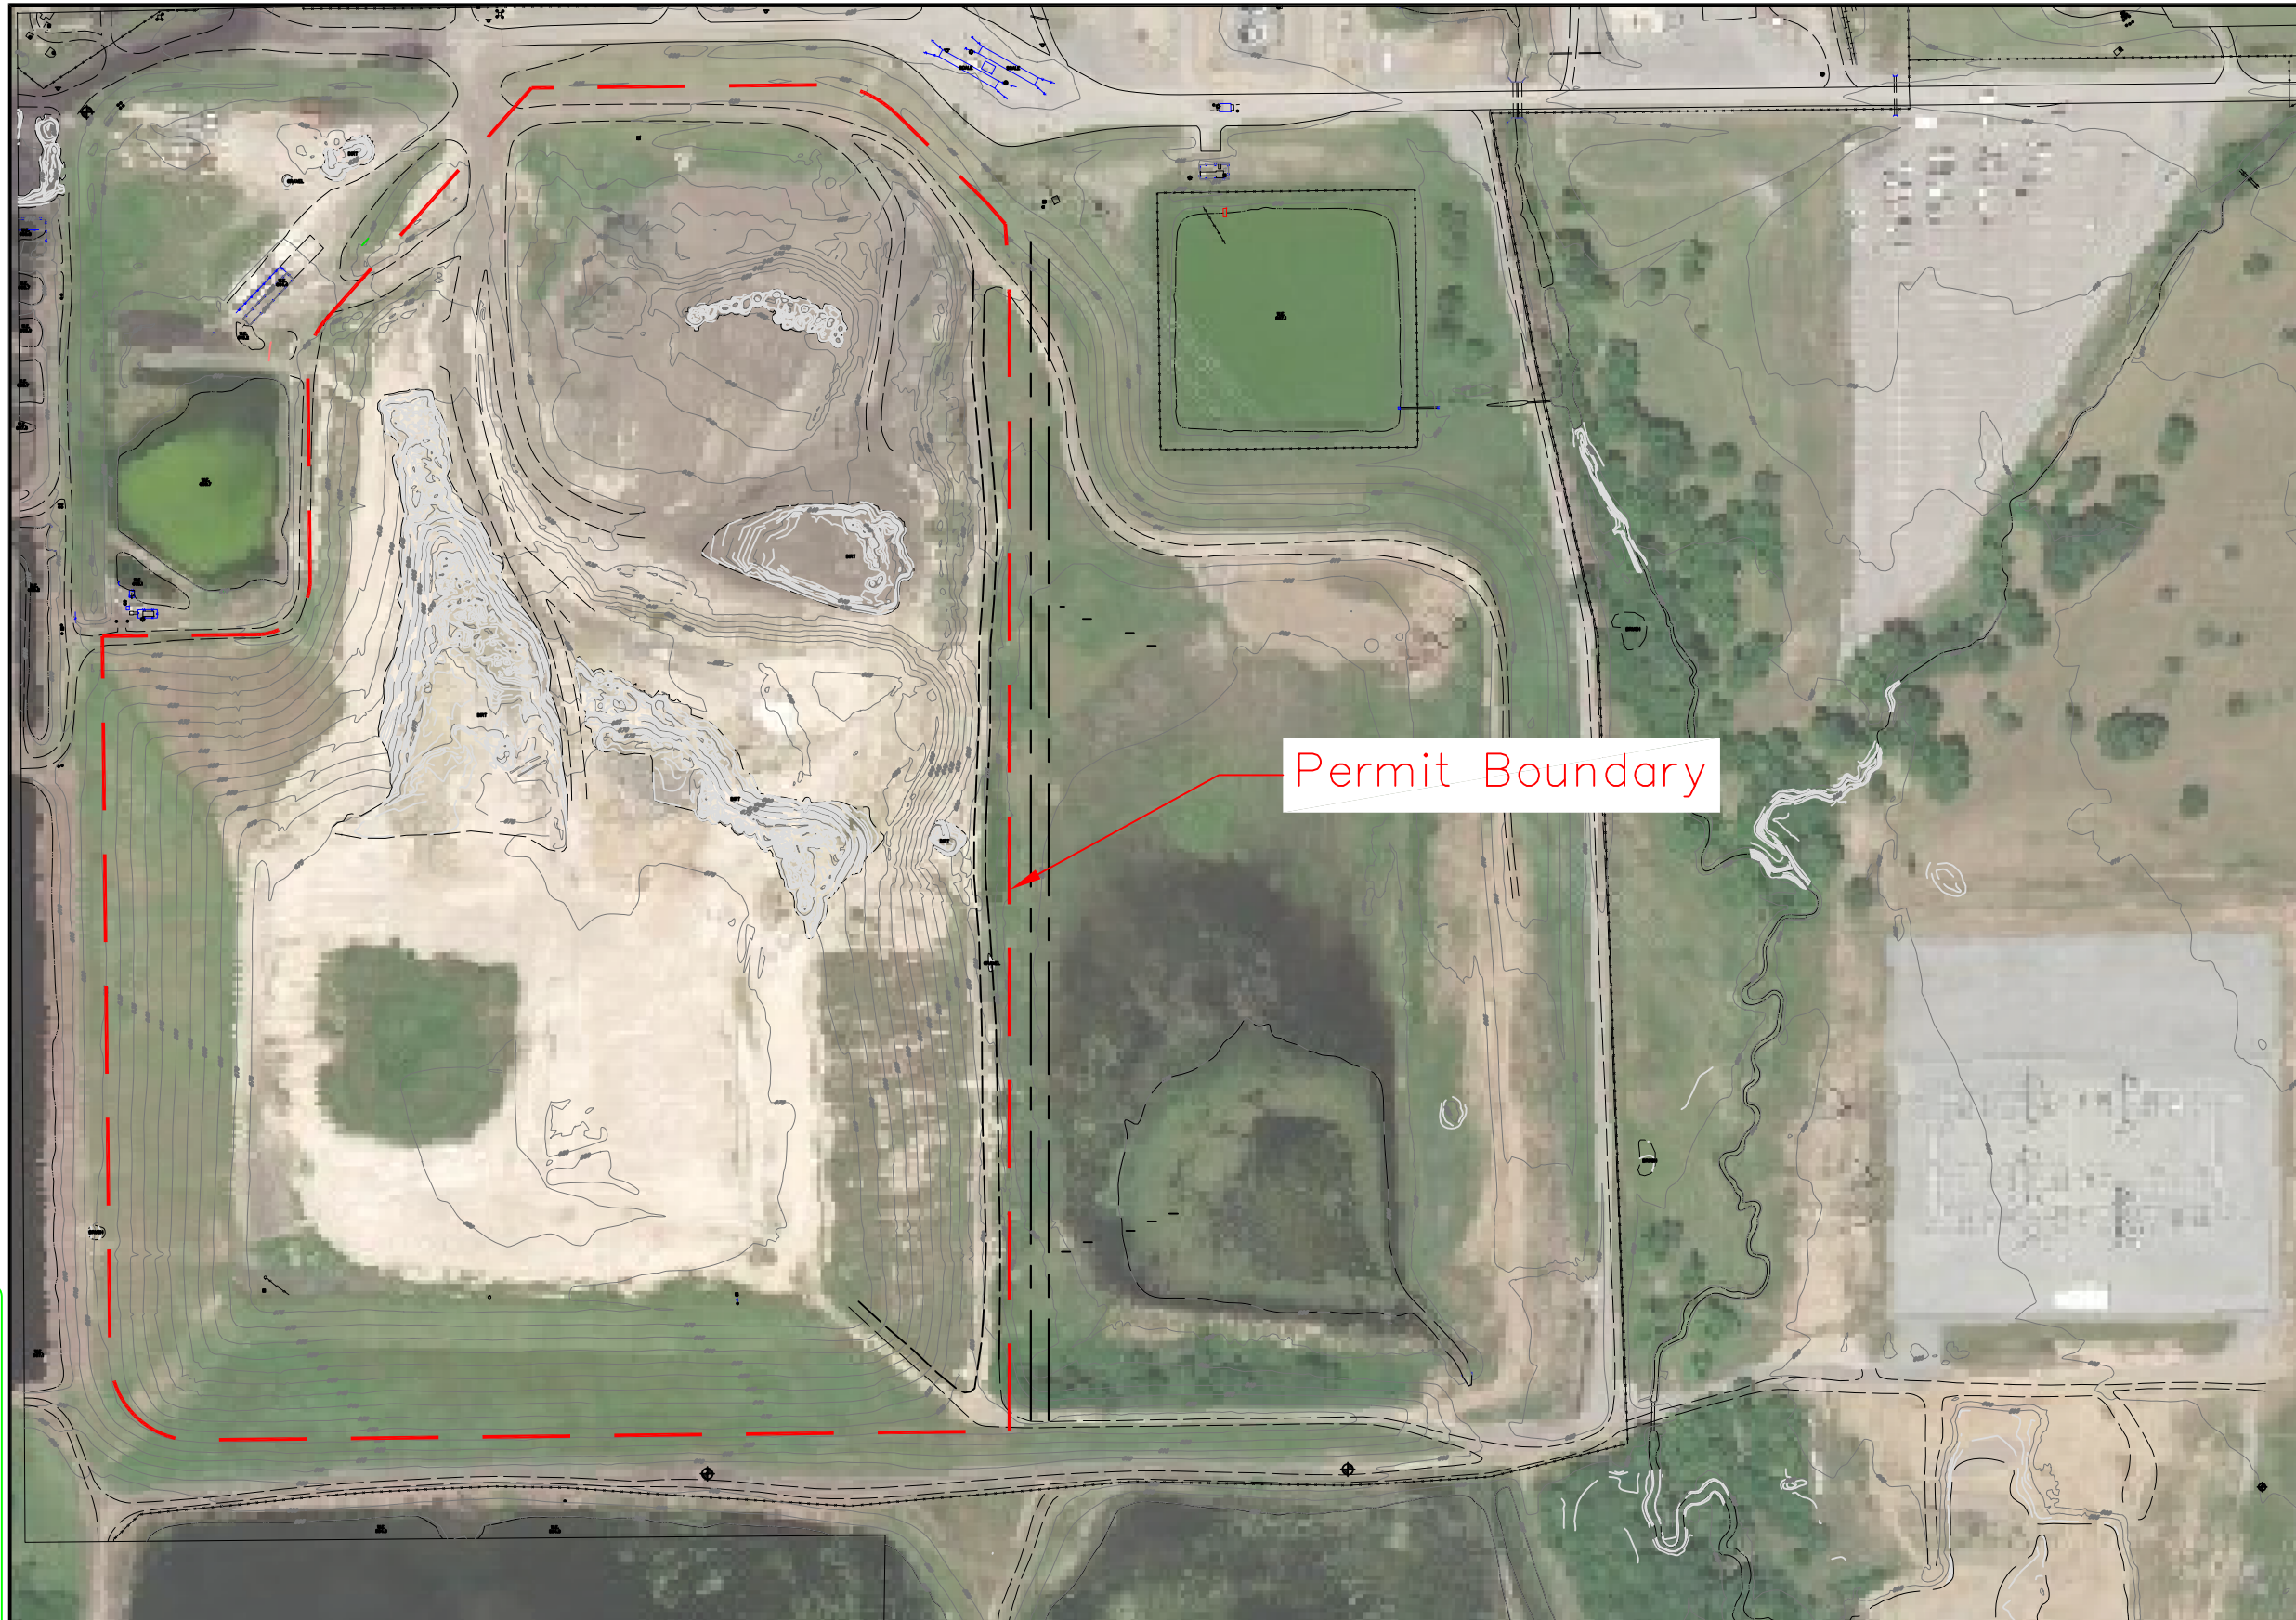
**SITE MAP**  
**GRAND RIVER DAM AUTHORITY LANDFILL**  
**CHOUTEAU, OKLAHOMA**

The permitted landfill limits are shown in **Figure 1**. Approximately 47 acres of this area have been utilized and remain active to date. The southern half of this area is near the maximum design elevation according to the facility Closure Plan. The elevation of the crest along the southern edge of the landfill is reported to be approximately 680 feet referenced to the NAVD 1988 vertical datum. The lowest point along the toe of dike is reported to be at approximately 606 feet. An intermediate or final cover has been installed on the southern and western exterior slopes of the landfill. These slopes are well vegetated and maintained. Precipitation run-off from the exterior slopes is collected within the wastewater impoundments around the landfill. The eastern and northern slopes of the active landfill are within the limits of the landfill perimeter dike. Precipitation run-off from the active landfill area is collected and evaporated or drained into the permitted industrial wastewater treatment system.

Based on the visual inspection of the landfill, the geometry does not appear to have changed significantly compared to the conditions documented in the 2017 annual landfill inspection report or the aerial photograph depicted in **Figure 1**. Primary fill activities remain at the top of the landfill and within the northern half of the active area. Intermediate or final cover was observed on the western and southern exterior slopes of the landfill with established and maintained vegetation.
