2020 ANNUAL INSPECTION REPORT

GRAND RIVER ENERGY CENTER - CCR LANDFILL

SOLID WASTE PERMIT NO. 3549012

14 DECEMBER 2020

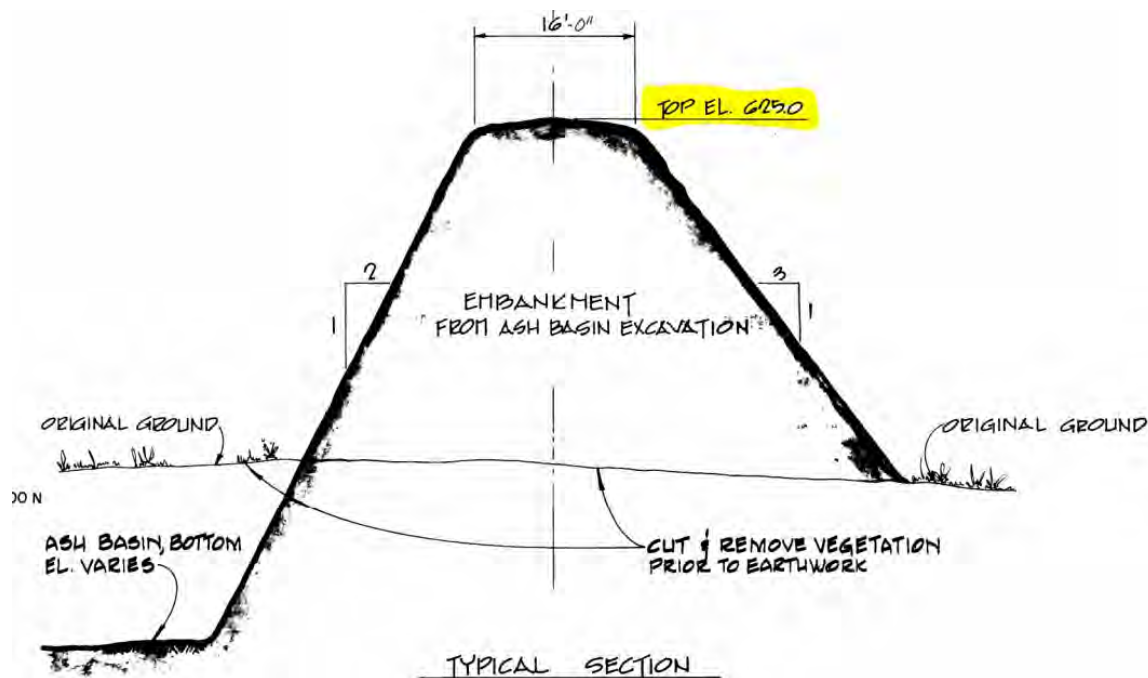
Figure 3-1 Original Design Drawing Cross-Section of Landfill Embankment

The original drawings for the landfill were completed in 1979 by Holway-United. The drawings show the embankments surrounding the landfill were constructed to Elevation 625 with a 16-foot wide top and 2 Horizontal to 1 Vertical side slopes, see Figure 3-1. Soil materials from inside the landfill area were used to construct the embankments.

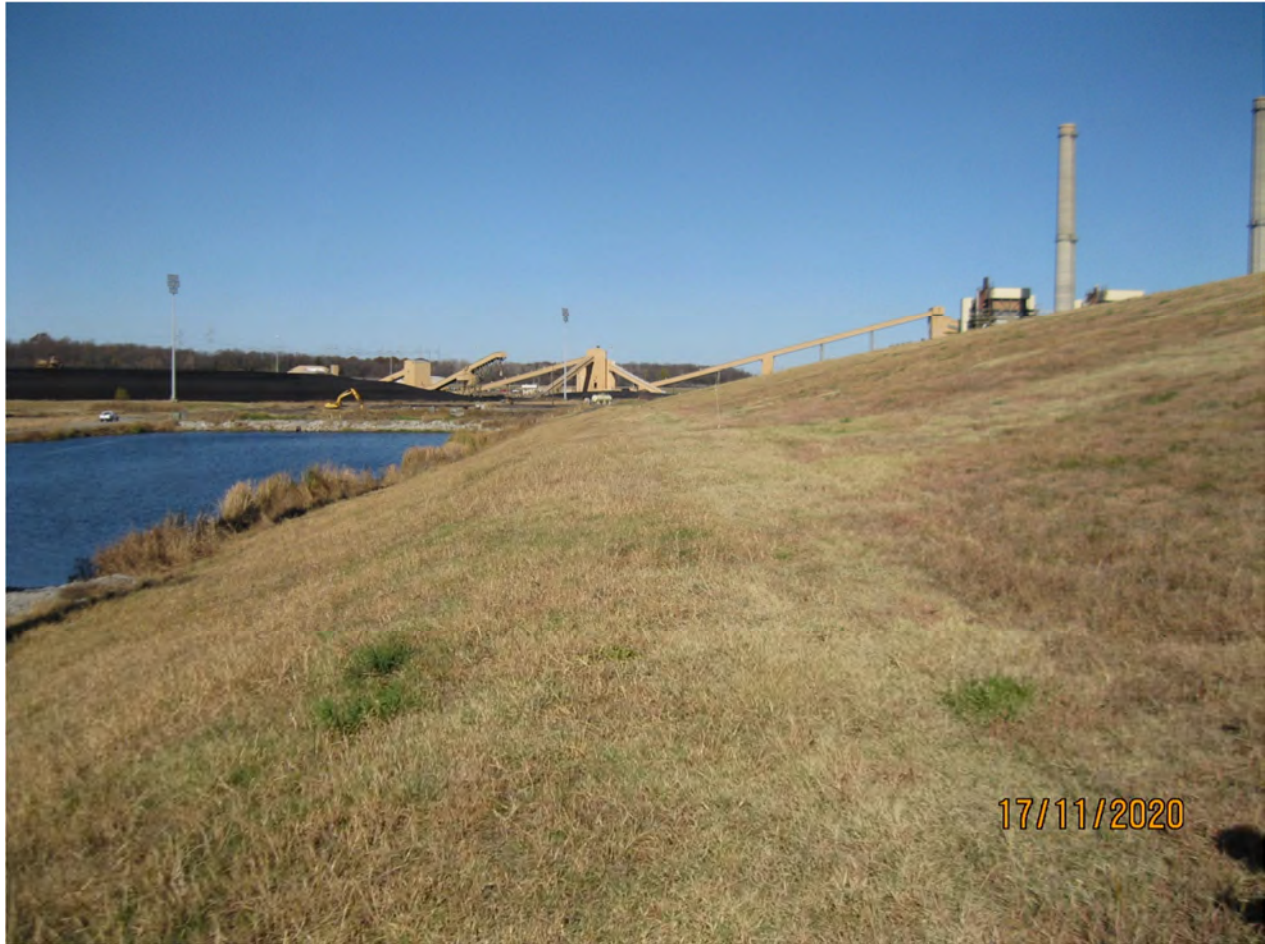
Figure 4-1 Field Photo of West Embankment, Looking North

The crest of the landfill embankments on the west and north sides are grass covered. The crest of the embankments had good grass cover, no signs of cracking, settlement, movement, erosion or deterioration. (See Figure 4-1). Mowing operations have maintained a good height for the grass and no unwanted vegetation (bushes or trees) were observed. No ruts or bare areas were observed on the crest. No depressions or slumps were observed that would indicated the beginnings of slope failure.

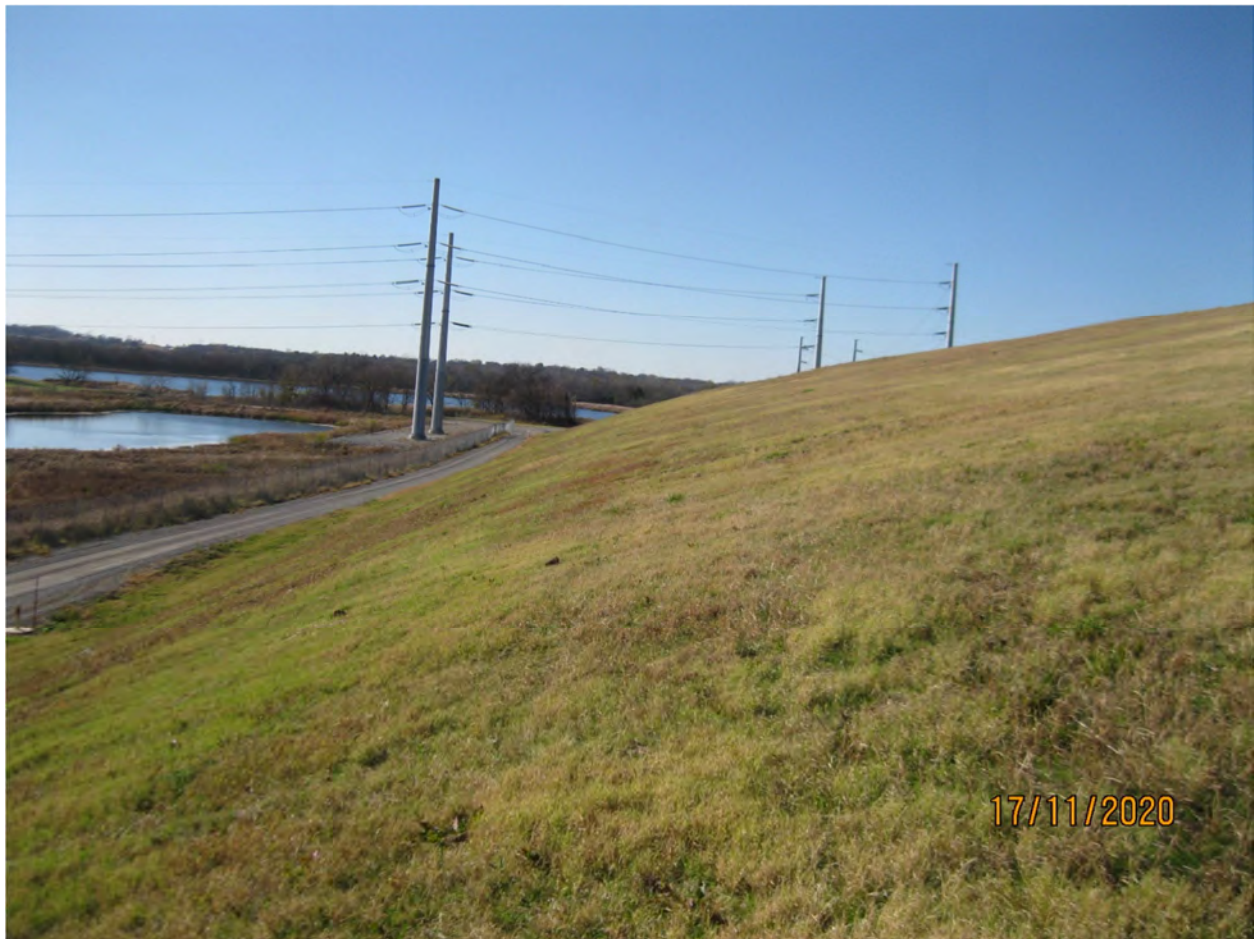
Figure 4-2 Final Cover on CCR Material – South Slope - Looking West

The areas of the CCR material that have reached final grade have been capped with the planned cover soil, topsoil, and grass seed. In general the cover soil observed on the closed portion of the landfill was the same condition as the exterior slopes of the embankment. The cover material on the landfill slopes has good grass cover and has been well maintained. There were minor areas of exposed ash on the side slopes along the southeast corner of the ash pile, but those areas are easily repaired with additional cover soil, topsoil, and seeding.
