2021 ANNUAL INSPECTION REPORT

GRAND RIVER ENERGY CENTER - CCR LANDFILL
SOLID WASTE PERMIT NO. 3549012

Chouteau, Oklahoma

22 DECEMBER 2021

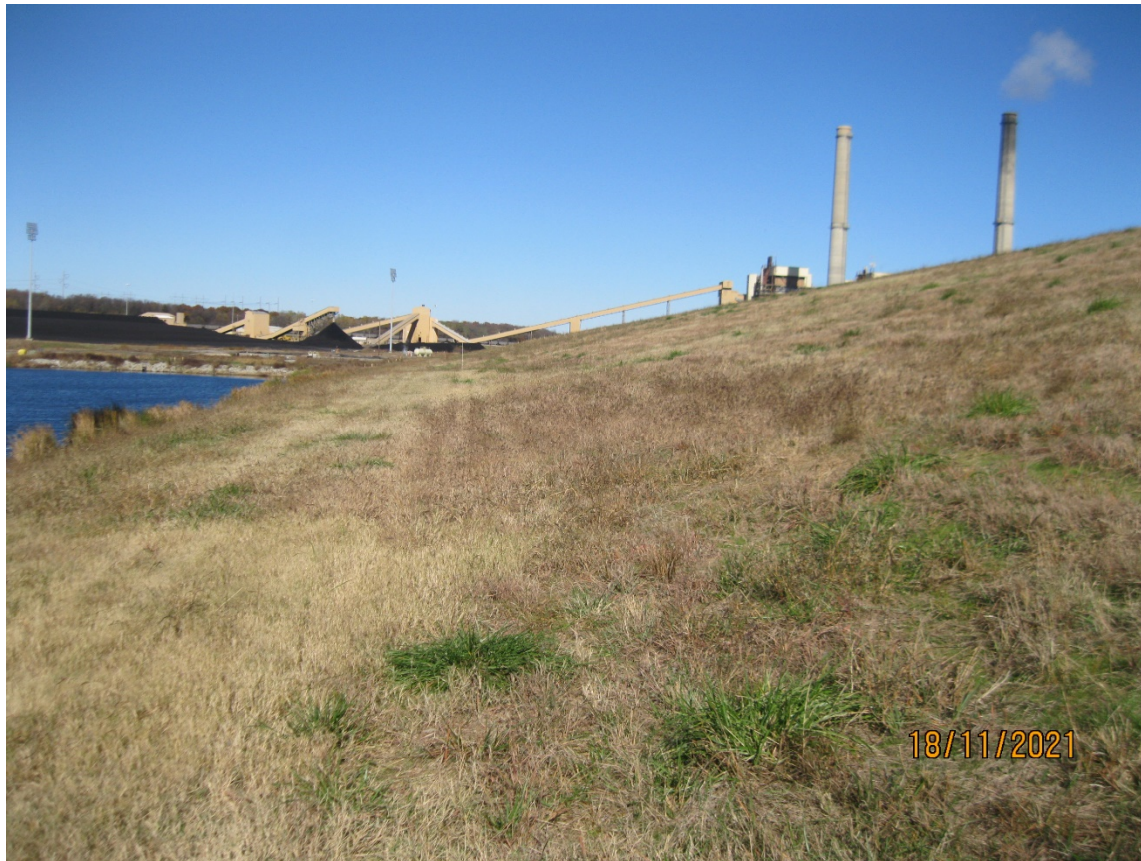
The crest of the landfill embankments on the south, west, and north sides are grass covered. The crest of the embankments had good grass cover, no signs of cracking, settlement, movement, erosion, or deterioration. (See Figure 4-1). Mowing operations have maintained a good height for the grass and no unwanted vegetation (bushes or trees) were observed. No ruts or bare areas were observed on the crest. No depressions or slumps were observed that would indicate the beginnings of slope failure. There were no erosion areas that could not be traversed by the mowing equipment and there were no apparent wet areas on the slopes.

Figure 4-1 – Crest of West Embankment, South End Looking North.

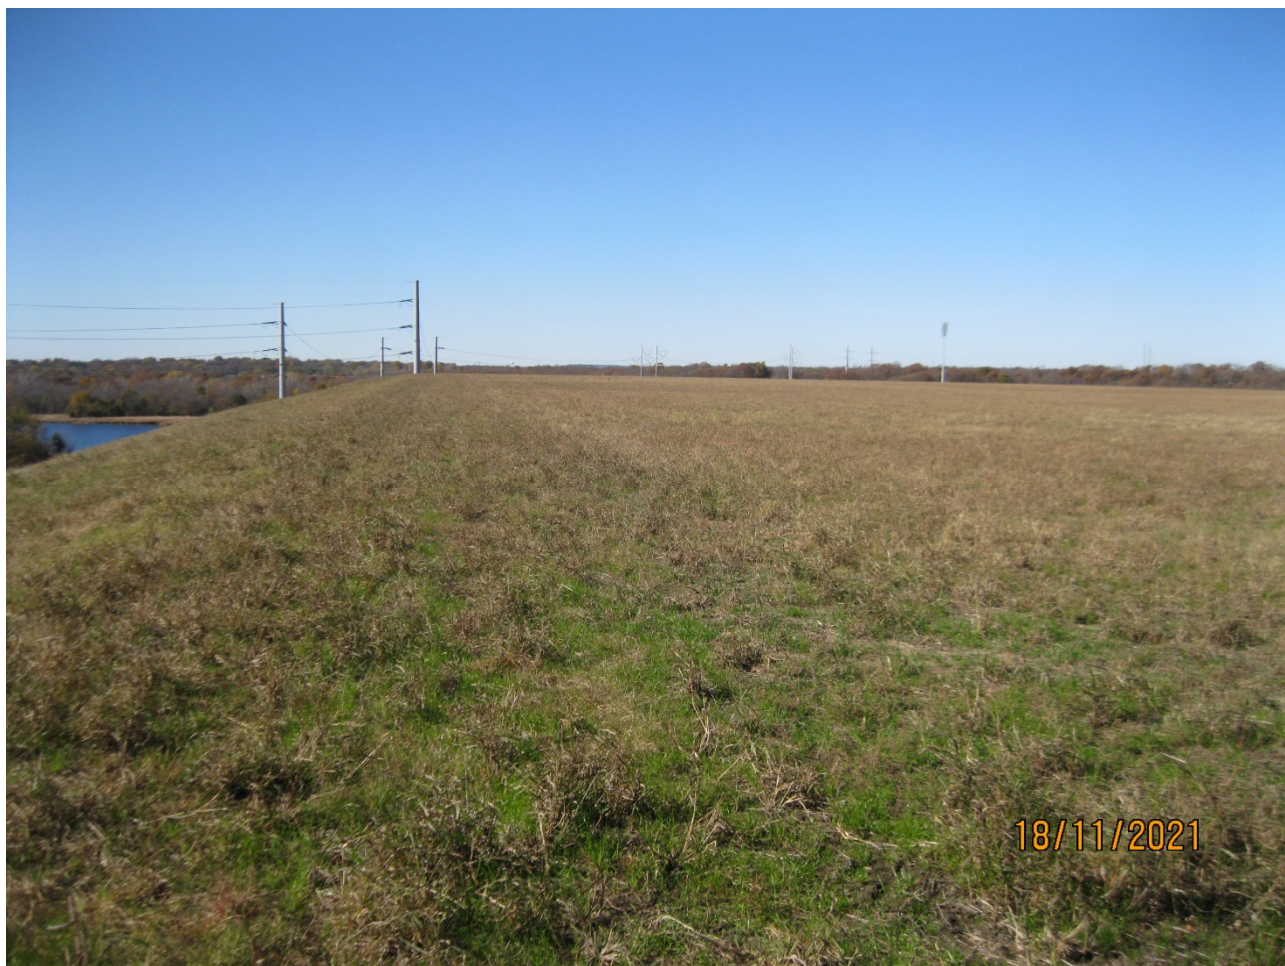
The exterior slopes of stockpiled CCR were capped with the cover soil, topsoil, and vegetation. There were no signs of unwanted vegetative growth, new encroachments, or settlement. There were no active erosion channels along the slopes. There were no erosion channels too deep for access by the mowing equipment. No wet or damp areas were observed that would indicate seepage. The grass has prevented active erosion within the small channels.

The areas of the CCR material that have reached final grade have been capped with the planned cover soil, topsoil, and grass seed. In general, the cover soil observed on the closed portion of the landfill was the same condition as the exterior slopes of the embankment.

Figure 4-2 Final Cover on CCR Material – South Slope and Top. Looking West

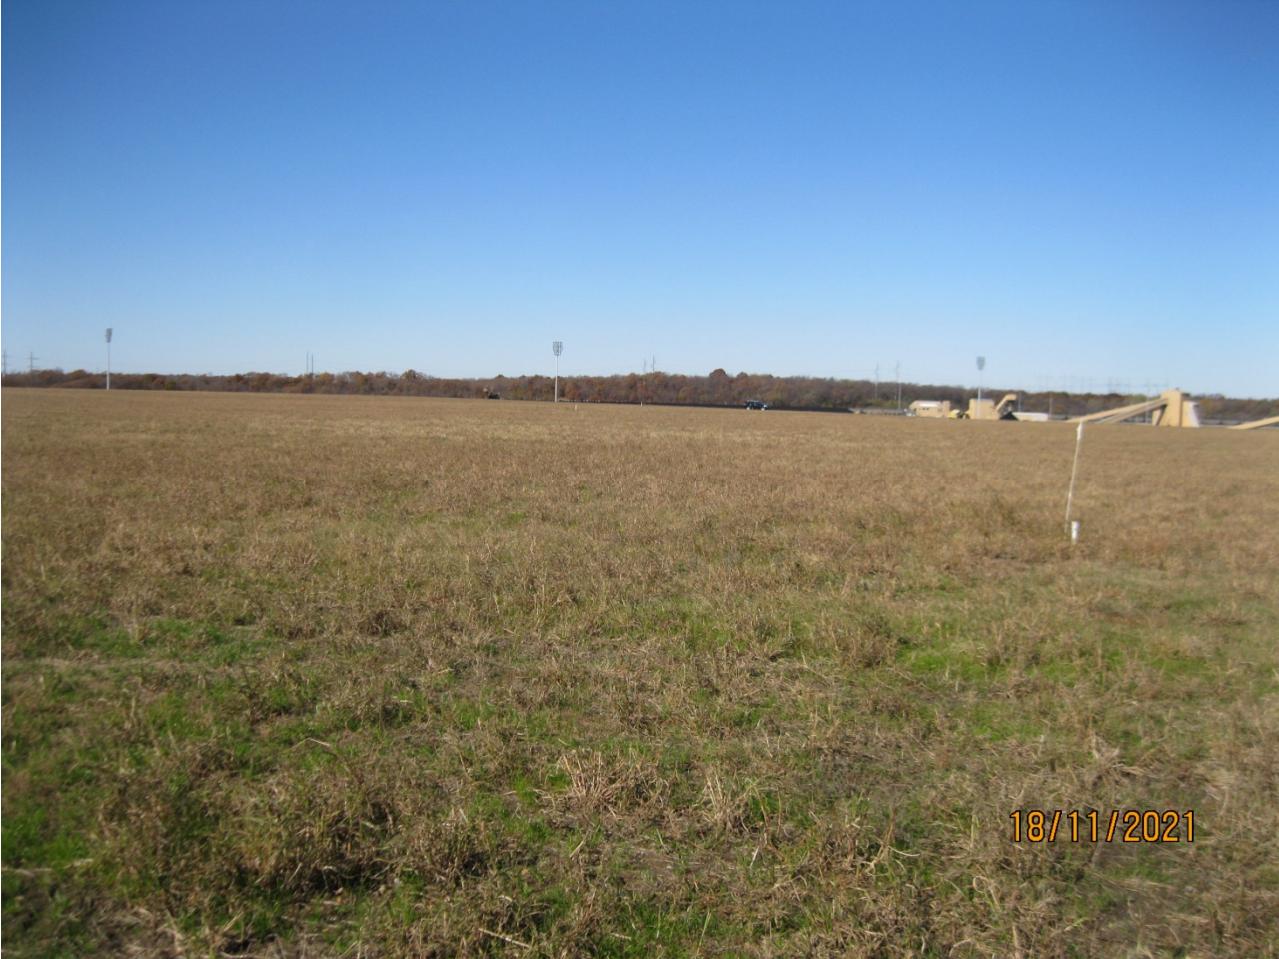
The top surface of the landfill area has been graded to slope toward the north and the area has been covered with the planned cover soils, topsoil, and vegetation. The areas that had been vegetated within the past year were not discernable from older areas indicated good growth and appropriate mowing that limits brush and trees.

Figure 4-3 Final Cover on CCR Material – Top of Landfill looking North.
