2022 ANNUAL INSPECTION REPORT

GRAND RIVER ENERGY CENTER - CCR LANDFILL
SOLID WASTE PERMIT NO. 3549012

Chouteau, Oklahoma

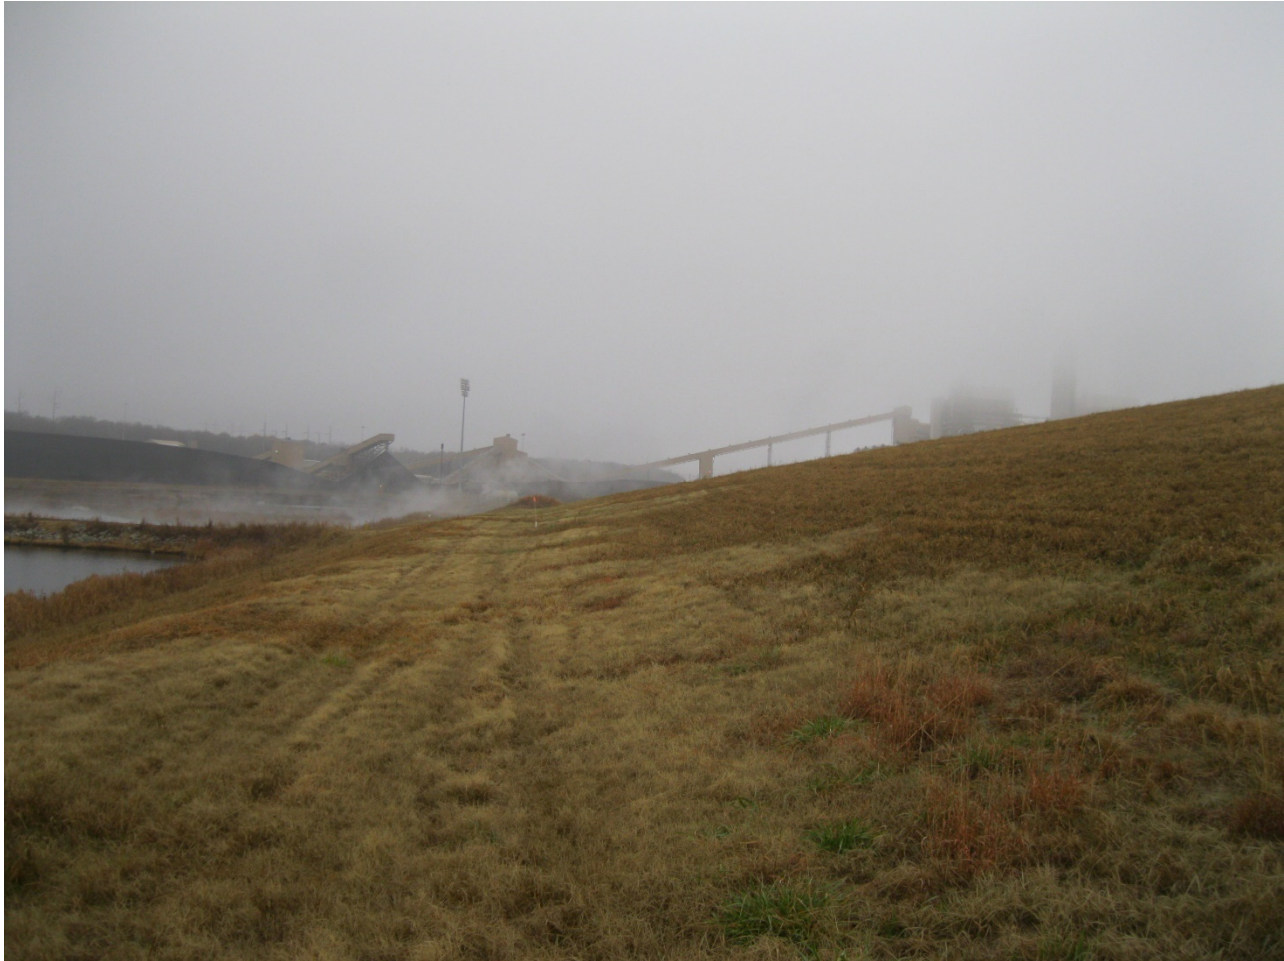
The crest of the landfill embankments on the south, west, and north sides are grass covered. The crest of the embankments had good grass cover, no signs of cracking, settlement, movement, erosion, or deterioration. (See Figure 4-1). Mowing operations have maintained a good height for the grass and no unwanted vegetation (bushes or trees) were observed. No ruts or bare areas were observed on the crest. No depressions or slumps were observed that would indicate the beginnings of slope failure. There were no erosion areas that could not be traversed by the mowing equipment and there were no apparent wet areas on the slopes.

Figure 4-1 – Crest of West Embankment, Center Looking North.

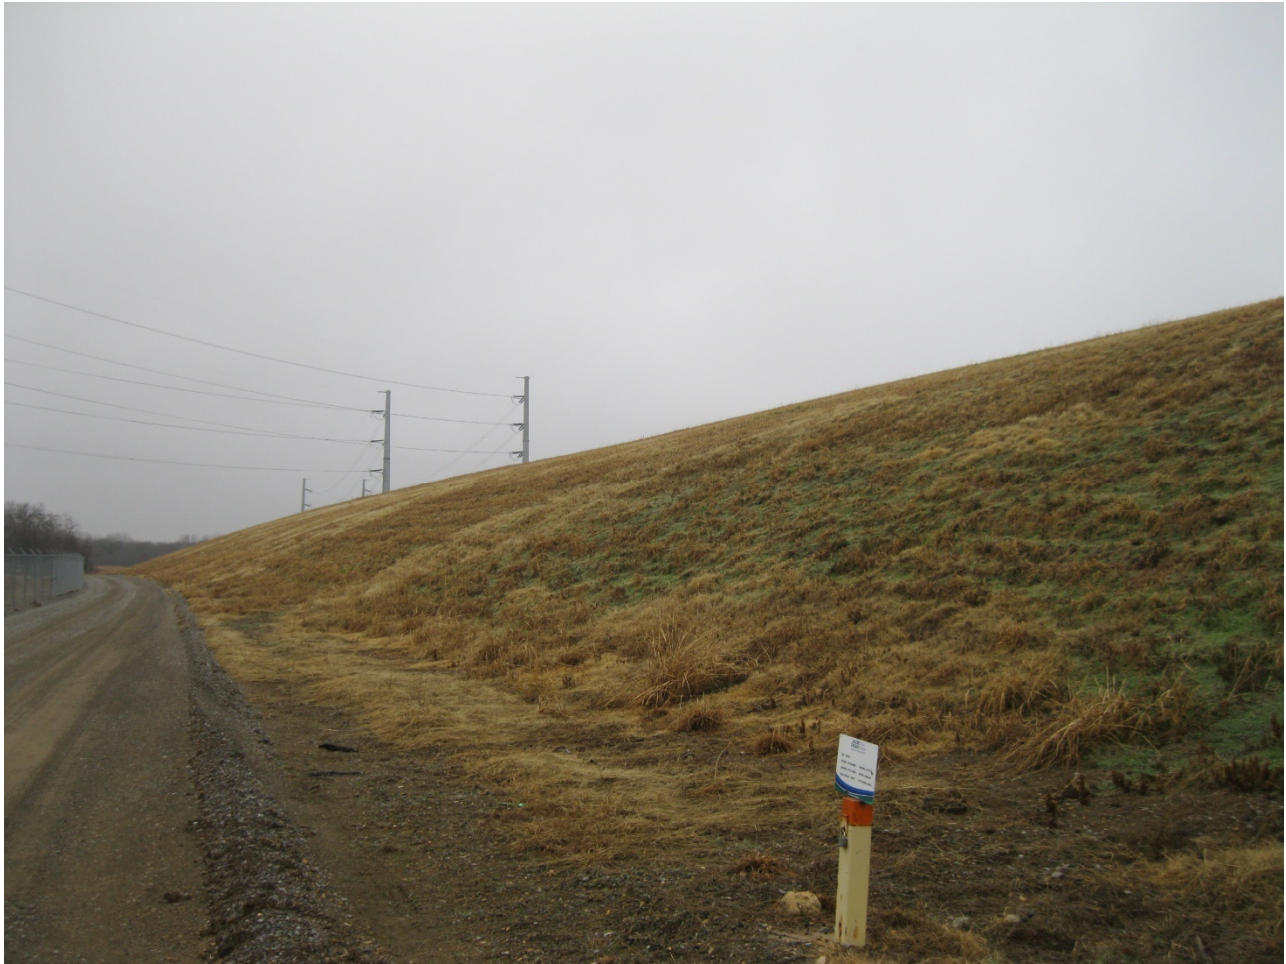
The exterior slopes of stockpiled CCR were capped with the cover soil, topsoil, and vegetation. There were no signs of unwanted vegetative growth, new encroachments, or settlement. There were no active erosion channels along the slopes. There were no erosion channels too deep for access by the mowing equipment. No wet or damp areas were observed that would indicate seepage. The grass has prevented active erosion.

Figure 4-2 – South CCR Slope and Embankment with Vegetation Cover. East Looking West.

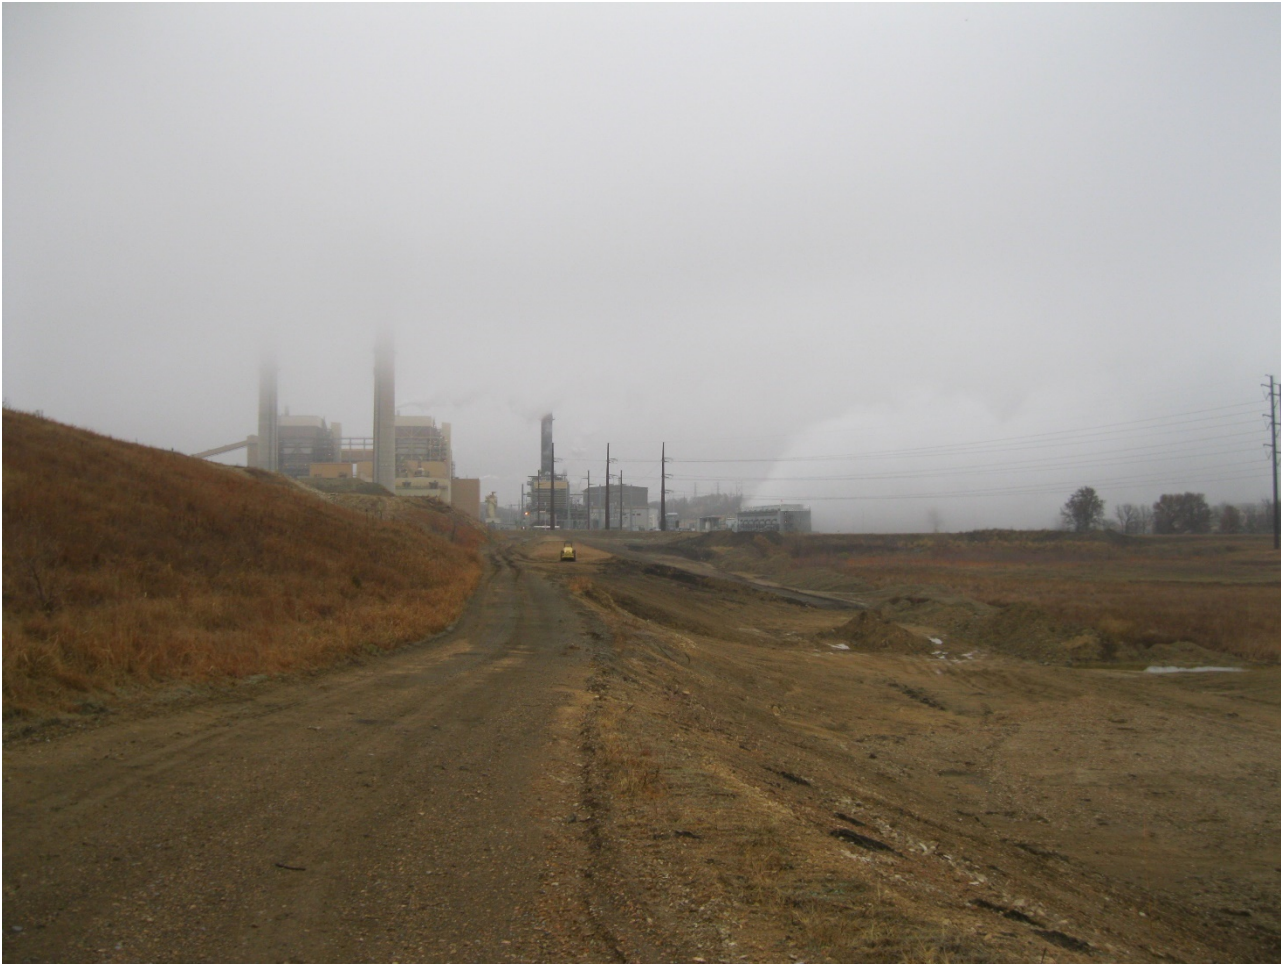
The areas of the CCR material that have reached final grade have been capped with the planned cover soil, topsoil, and grass seed. In general, the cover soil observed on the closed portion of the landfill was the same condition as the exterior slopes of the embankment. Areas of the south CCR landfill have grass cover on areas that are not yet fully closed. The grass cover provides runoff and erosion protect. This is observed on the east side of the CCR material adjacent to the new

embankment that under construction (Figure 4-3)

Figure 4-3 East CCR material with new embankment construction, South Looking North

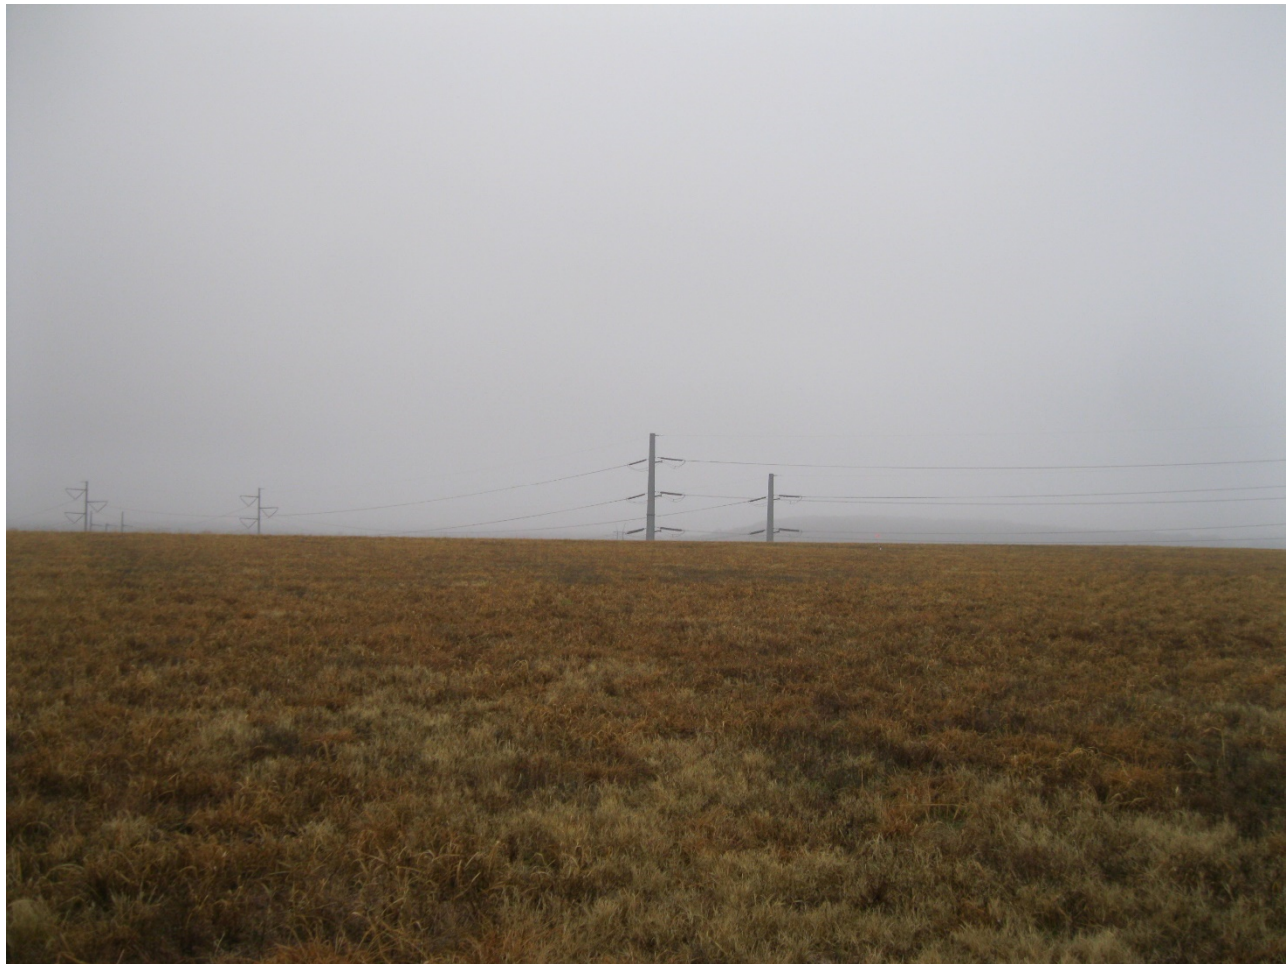
Figure 4-3 Final Cover on top of CCR Material – Top of Landfill from Center looking Southwest

The top surface of the landfill area has been graded to slope toward the north and the area has been covered with the planned cover soils, topsoil, and vegetation. The areas that had been vegetated within the past year were not discernable from older areas indicated good growth and appropriate mowing that limits brush and trees.
