# 2023 ANNUAL INSPECTION REPORT

GRAND RIVER ENERGY CENTER - CCR LANDFILL  
SOLID WASTE PERMIT NO. 3549012

Chouteau, Oklahoma

7 DECEMBER 2023

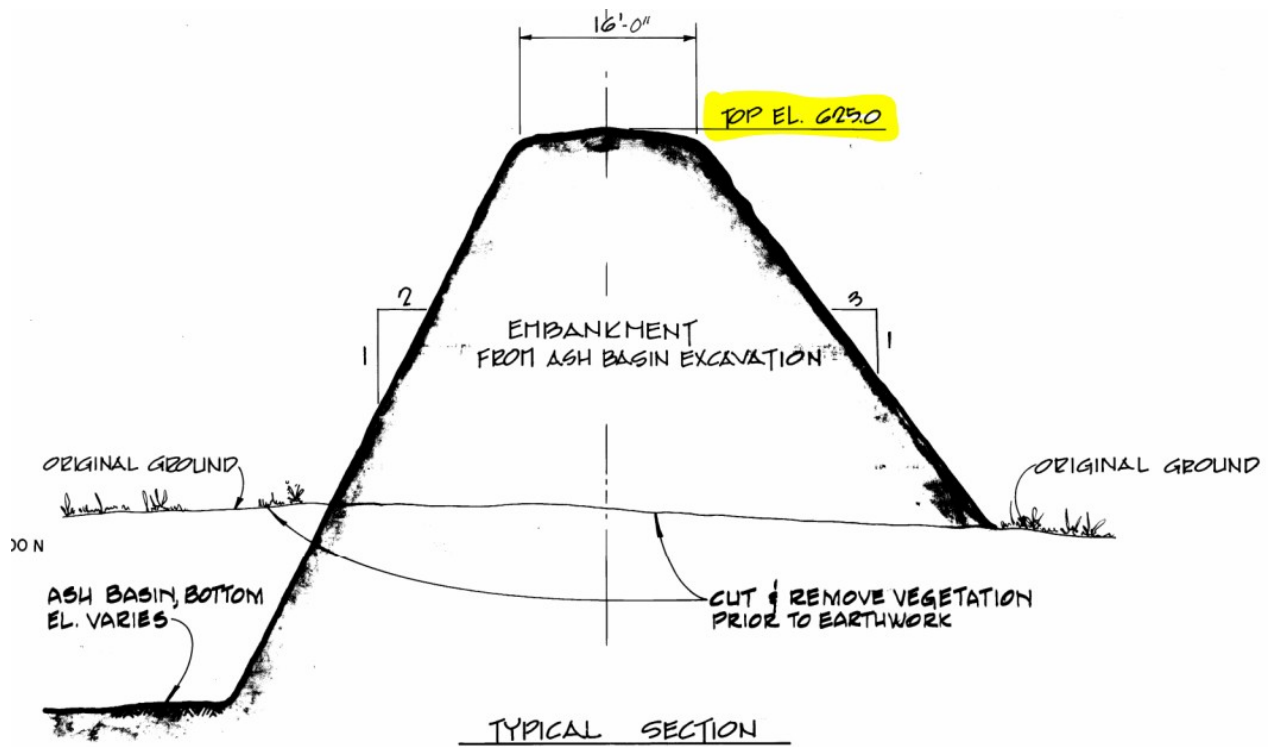
**Figure 3-1 Original Design Drawing Cross-Section of Landfill Embankment**

In October 2017, a request to modify the existing landfill permit was submitted to DEQ. The modification requested a reduction in landfill permit area from 116 acres to 67 acres. The request for permit modification has been approved by DEQ. The original drawings for the landfill were completed in 1979 by Holway-United. The drawings show the embankments surrounding the landfill were constructed to Elevation 625 with a 16-foot wide top and 2 Horizontal to 1 Vertical side slopes, see Figure 3-1. The native soil materials from inside the landfill footprint were used to construct the embankments.

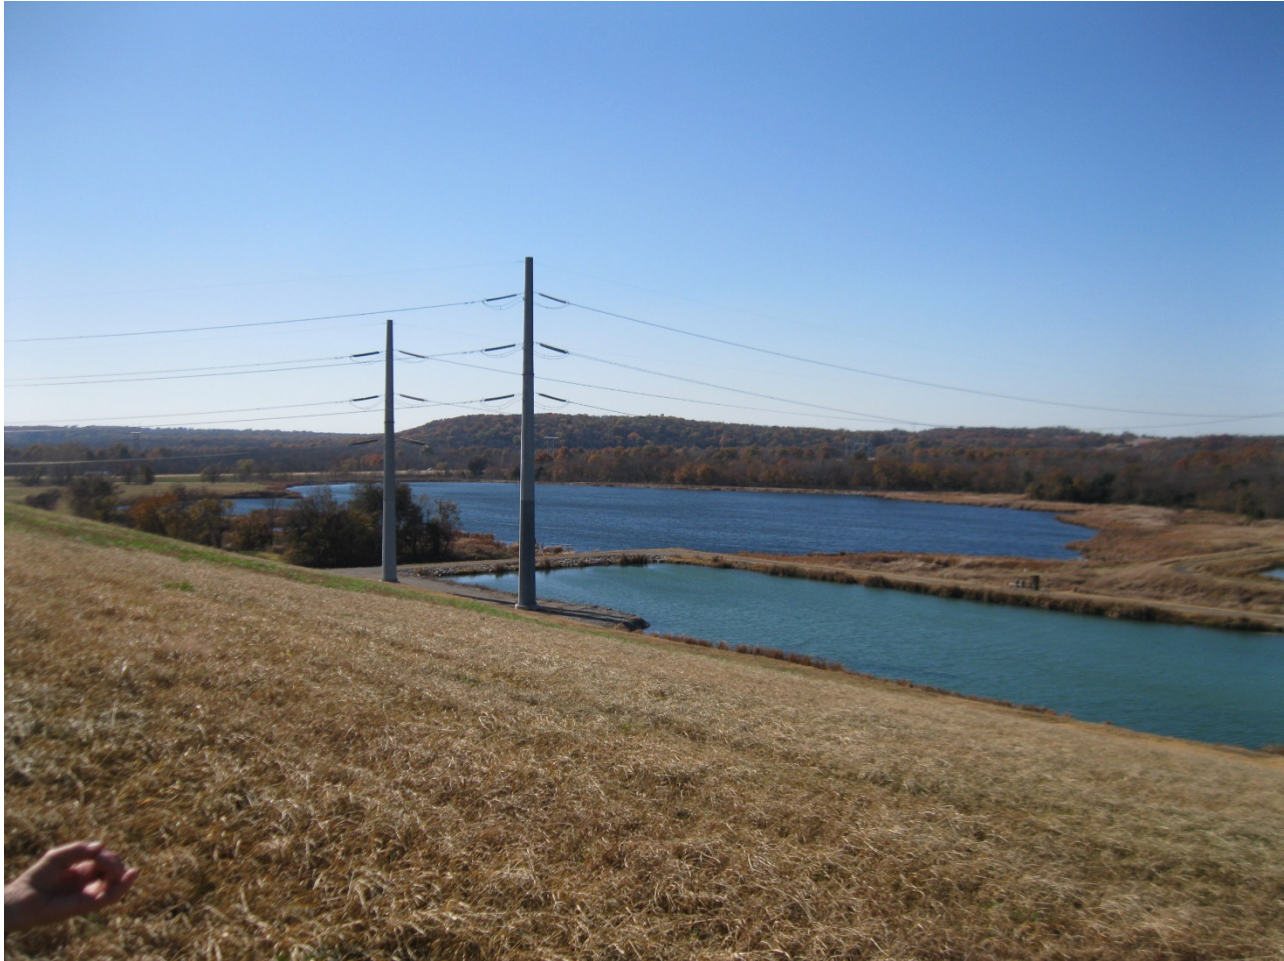
The crest of the landfill embankments on the south, west, and north sides are grass covered. The crest of the embankments had good grass cover, no signs of cracking, settlement, movement, erosion, or deterioration. (See Figure 4-1). The grass height is maintained to ensure there is no unwanted vegetation (bushes or trees). No ruts or bare areas were observed on the crest. No depressions or slumps were observed that would indicate the beginnings of slope failure. There were no erosion areas that could not be traversed by the mowing equipment and there were no apparent wet areas on the slopes.

**Figure 4-1 –Top of West Landfill, Center Looking South.**

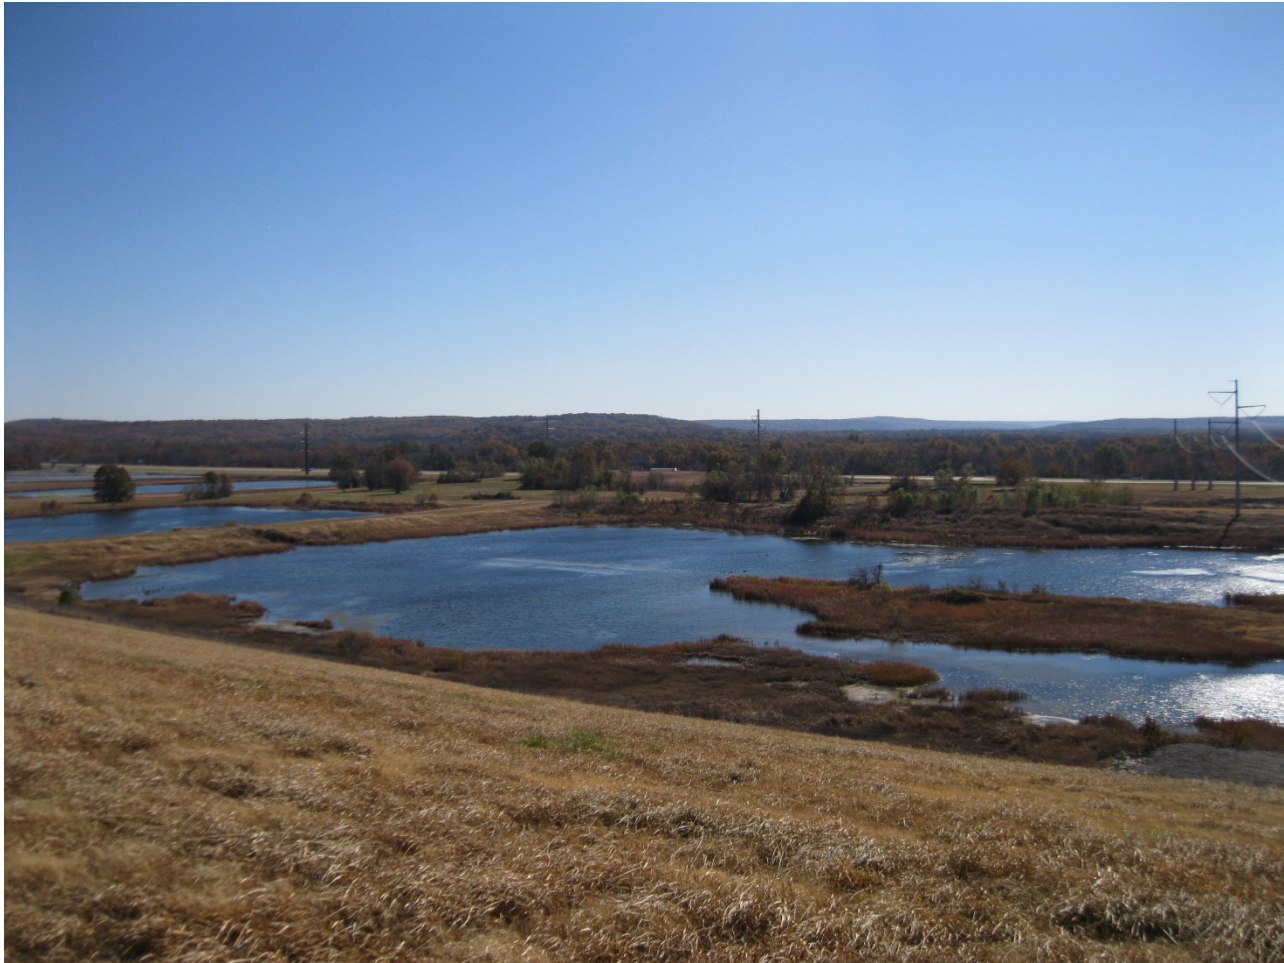
The exterior slopes of stockpiled CCR were capped with the cover soil, topsoil, and vegetation. There were no signs of unwanted vegetative growth, new encroachments, or settlement. There were no active erosion channels along the slopes. There were no erosion channels too deep for

access by the mowing equipment. No wet or damp areas were observed that would indicate seepage. The grass has prevented active erosion.

**Figure 4-2 – South CCR Slope and Embankment with Vegetation Cover. Looking South.**

There was no indication that some sod cover had more growth due to higher moisture contents. There were no signs of slope stability problems and no signs of depression caused by slumping ground. There was no indication of animal burrows or animal tracks leading to burrows.

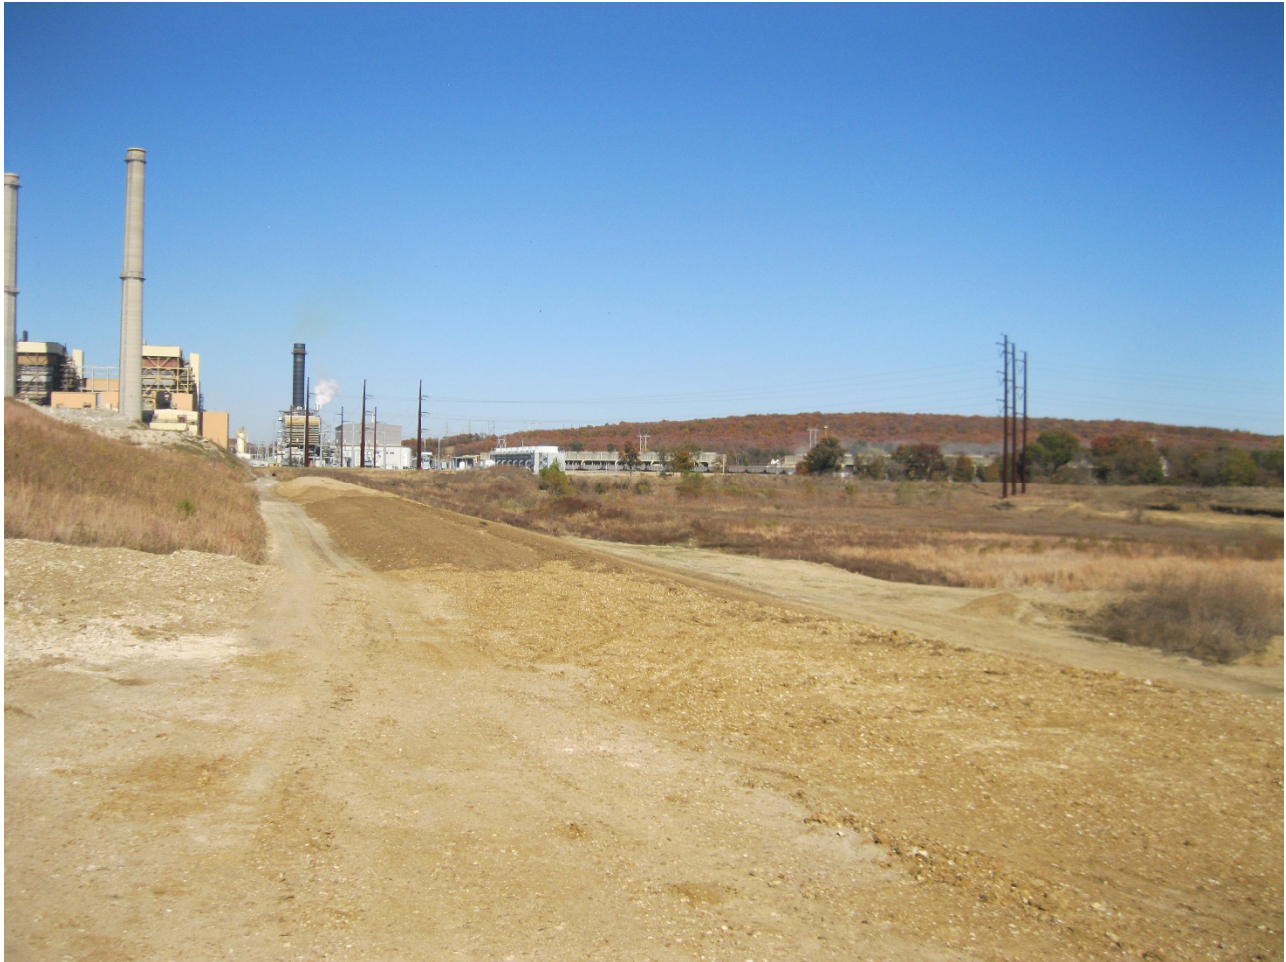
The areas of the CCR material that have reached final grade have been capped with the planned cover soil, topsoil, and grass seed. In general, the cover soil observed on the closed portion of the landfill was the same condition as the exterior slopes of the embankment. Areas of the south CCR landfill have grass cover on areas that are not yet fully closed. The grass cover provides runoff and erosion protect. This is observed on the east side of the CCR material adjacent to the new embankment that under construction (Figure 4-3)

**Figure 4-3 East CCR material with new embankment construction, South Looking North**

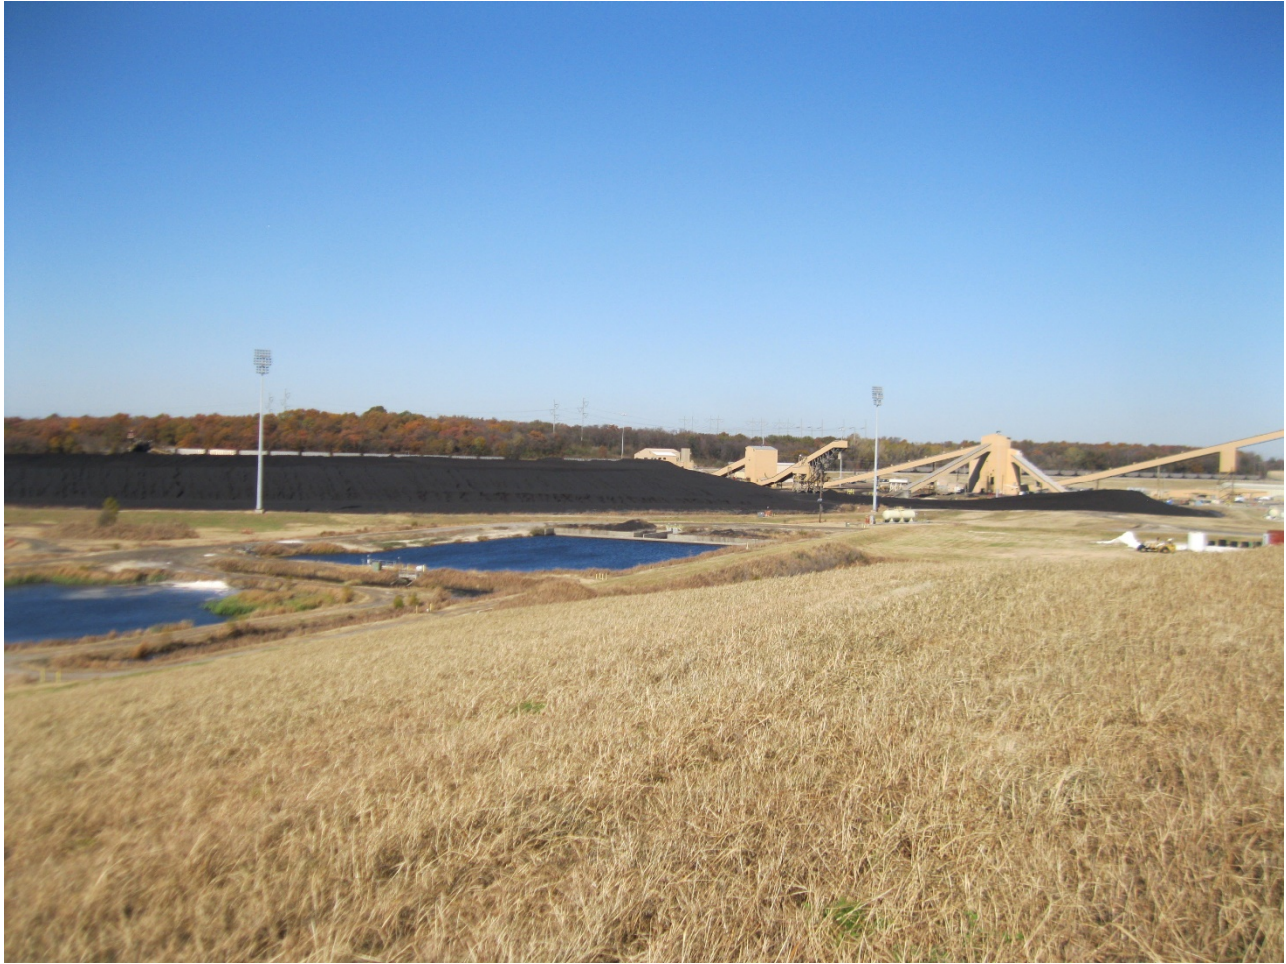
**Figure 4-3 Final Cover on top of CCR Material – Top of Landfill from Center looking Northwest**

The top surface of the landfill area has been graded to slope toward the north and the area has been covered with the planned cover soils, topsoil, and vegetation. The areas that had been vegetated within the past year were not discernable from older areas indicated good growth and appropriate mowing that limits brush and trees.
