# 2024 ANNUAL INSPECTION REPORT

**GRAND RIVER ENERGY CENTER - CCR LANDFILL  
SOLID WASTE PERMIT NO. 3549012**

Chouteau, Oklahoma

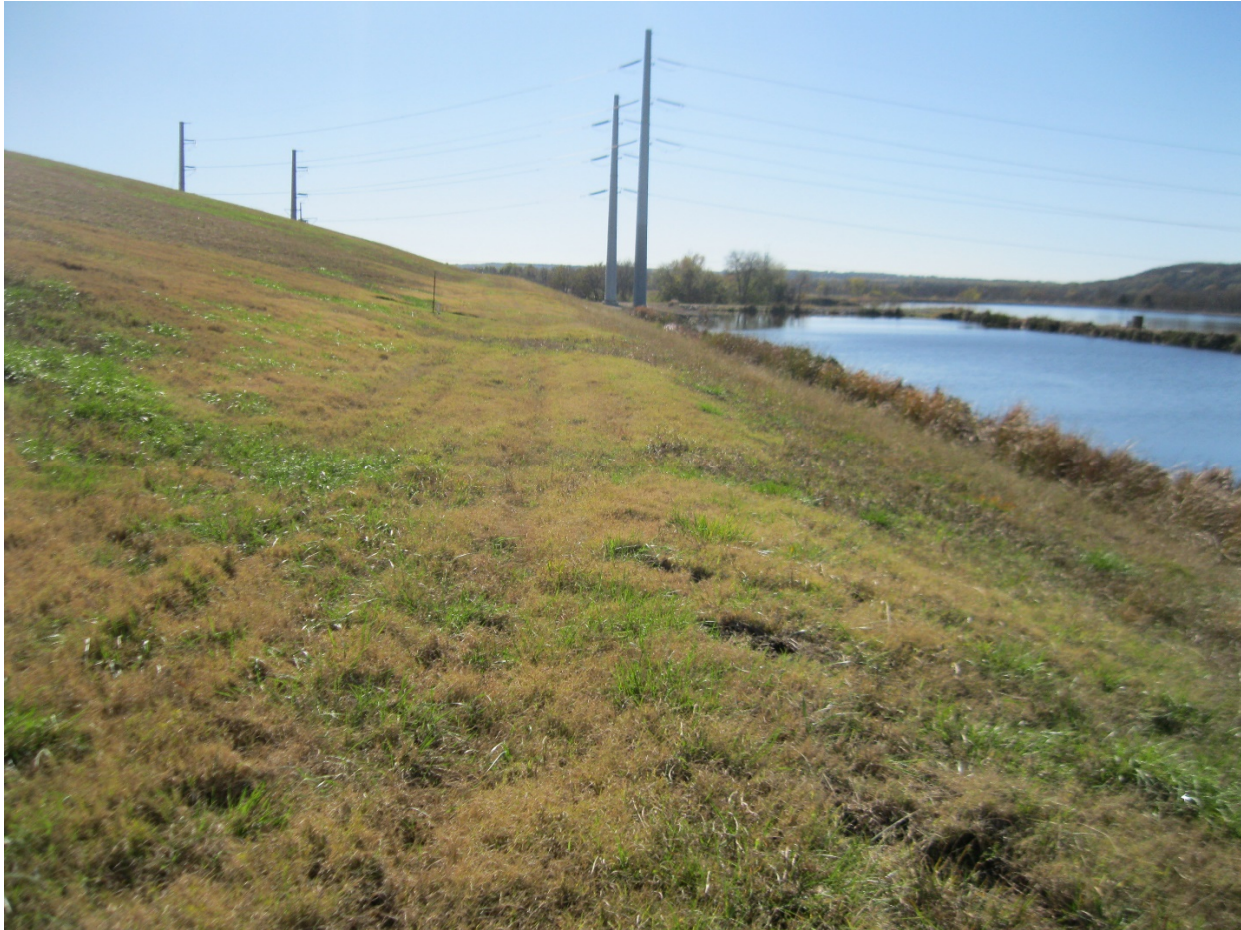
The crest of the landfill embankments on the south, west, and north sides are grass covered. The crest of the embankments had good grass cover, no signs of cracking, settlement, movement, erosion, or deterioration. (See Figure 4-1). The grass height is maintained to ensure there is no unwanted vegetation (bushes or trees). No ruts were observed on the crest. Bare spots of topsoil shows the grass has sheared at the top of the soil and appears related to mowers sliding on wet grass. Small bare spots can be seen in Figure 4-1. Rutting was not observed.

**Figure 4-1 –Top of Crest – West Slope, looking south.**

Black & Veatch recommends that mowing operations should not occur immediately after significant rainfall events. The intent is to reduce the potential for sliding of mowers on the slopes and shear of the vegetation from the topsoil.

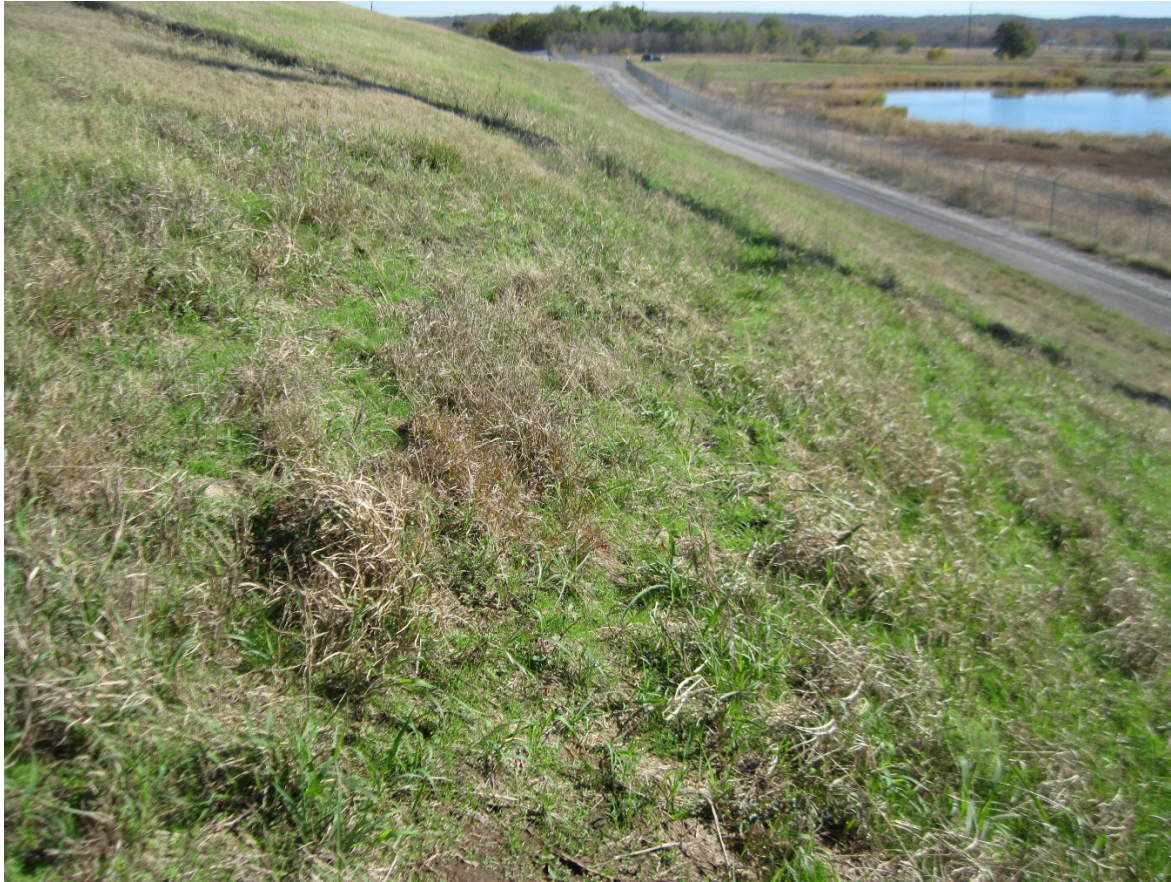
The exterior slopes of stockpiled CCR were capped with the cover soil, topsoil, and vegetation. There were no signs of unwanted vegetative growth, new encroachments, or settlement. There were no active erosion channels along the slopes. There were no erosion channels too deep for access by the mowing equipment. No wet or damp areas were observed that would indicate seepage. The grass has prevented active erosion.

**Figure 4-2 – South CCR Slope and Embankment with Vegetation Cover. Looking East.**

There was no indication that some sod cover had more growth due to higher moisture contents. There was some signs of mowers sliding on the slope, but no loss of topsoil or rutting was observed. There was no indication of animal burrows or animal tracks leading to burrows.

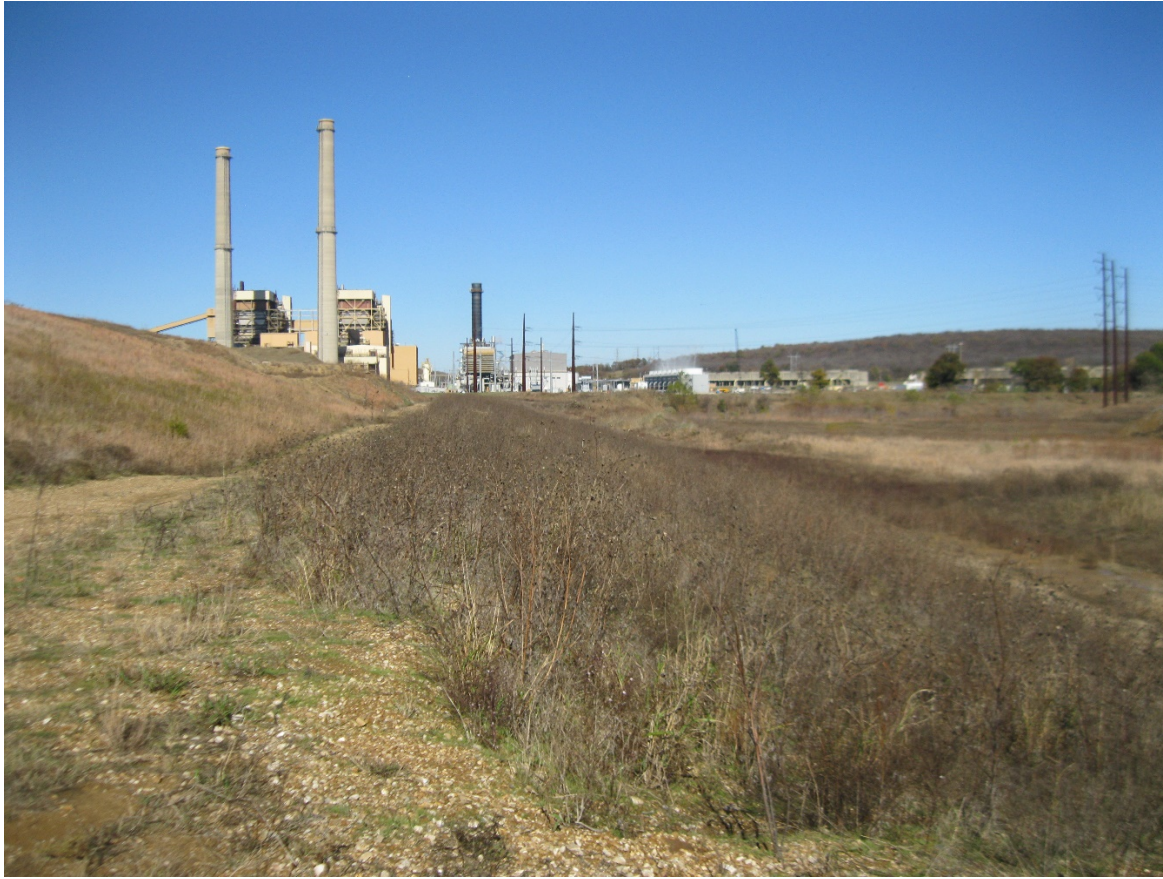
The areas of the CCR material that have reached final grade have been capped with the planned cover soil, topsoil, and grass seed. In general, the cover soil observed on the closed portion of the landfill was the same condition as the exterior slopes of the embankment. Areas of the south CCR landfill have grass cover on areas that are not yet fully closed. The grass cover provides runoff and erosion protect. This is observed on the east side of the CCR material adjacent to the new embankment that under construction (Figure 4-3)

**Figure 4-3 Top of CCR – East Slope, without final cover**
